# Earthquake Risk Management for Mini-Hydro Power Plant: A Case Study Approach

This study evaluates the impact of an earthquake on a mini-hydropower plant (MHP) and formulates a disaster management strategy to enhance the operational resilience of MHPs against seismic events. Data was collected through interviews with relevant stakeholders, direct observations, and analysis of pertinent documents. The findings indicate that the 2018 Lombok earthquake caused severe damage to the catchment area, triggering increased sedimentation that disrupted the MHP's operation, resulting in decreased electricity production and escalated operational costs. Mitigation measures were implemented and proved effective in reducing debris-related downtime and improving electricity generation. These findings are expected to provide guidance for MHP operators in mitigating the negative impacts of earthquakes and similar disasters on plant operations.

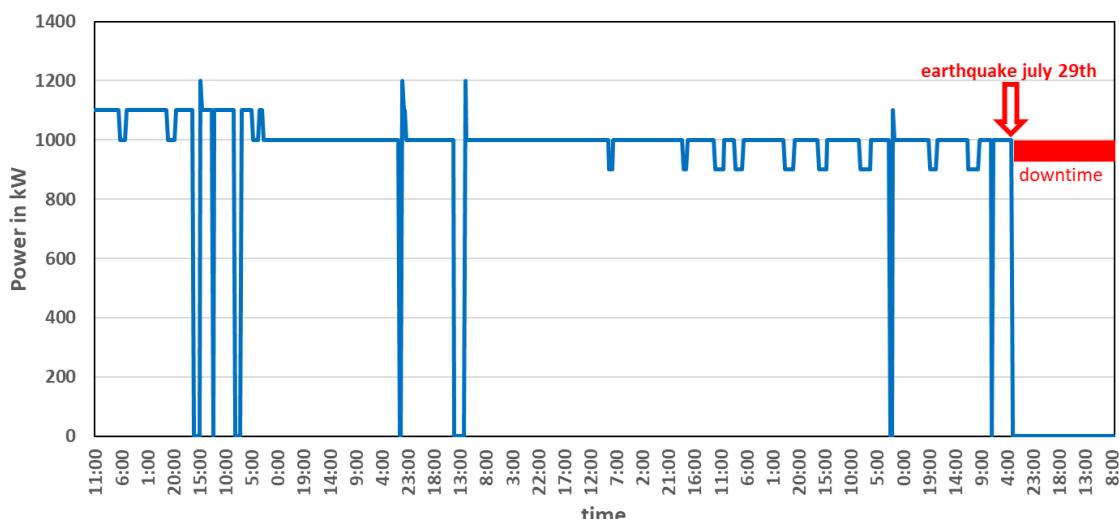
Figure 1. Power Production in July, 2018

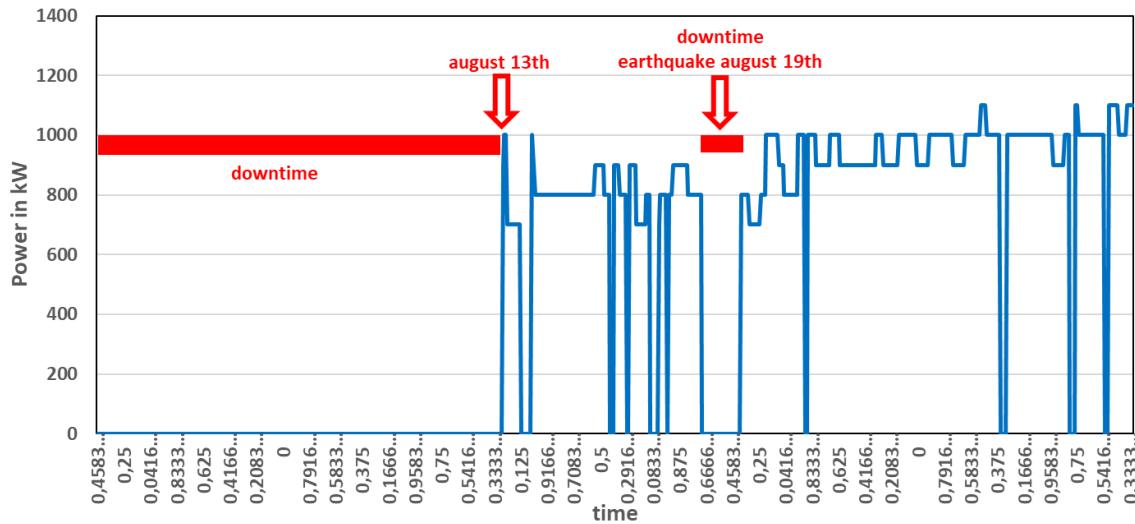
Figure 2. Power Production in August, 2018

Figure 2 also illustrates that, following the resumption of operations, the system continued to experience frequent disruptions, necessitating the shutdown of the power plant. These disruptions stemmed from disturbances within the electrical grid, primarily attributed to cable repairs, pole replacements, pole collapses, fallen trees, and other consequential events in the aftermath of the earthquake. In the instance of the seismic event on August 19th, the power plant was deactivated and rendered inoperable for a duration of 28 hours.

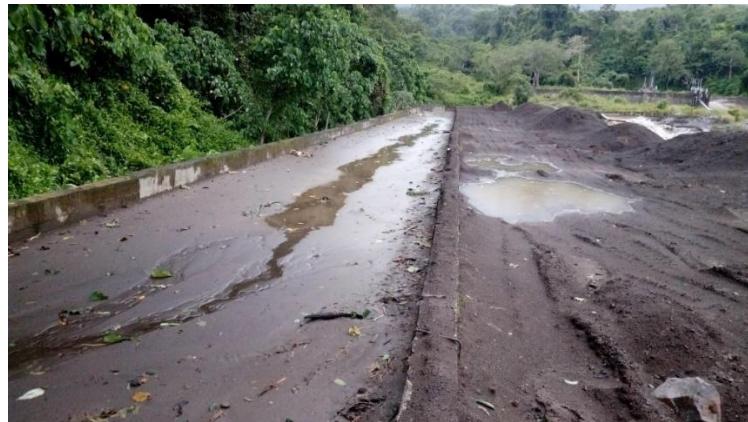
**Figure 3.** Image of the Channel During the Rainy Season (Documentation, January 23, 2019)

This disruption not only elevates the risk of sediment accumulation in the channel (Figure 3) but also leads to blockage of the hydropower plant intake by rocks and debris carried by the water flow. This accumulation of sediment and intake blockage directly contributes to increased operational downtime, necessitating more intensive and frequent maintenance to ensure the smooth flow of water and the continued operation of power plants.

A significant sedimentation phenomenon occurred within the hydropower plant's catchment area following the earthquake. This phenomenon commenced in November and December 2018, with a relatively low intensity. The intensity of sedimentation then escalated substantially from January to March 2019, before beginning to subside in early April 2019. This surge in sedimentation intensity is closely correlated with the rainy season in the region. High precipitation within the catchment area carries materials such as sediment, rocks, and logging debris into the rivers and streams leading to the hydropower plant. These materials subsequently accumulate in the channels and intake, leading to channel overfilling and blockage of the intake, ultimately preventing water from reaching the plant's turbine system.

To address the production decline caused by frequent downtime resulting from intake blockage and sediment accumulation in the water channels, the following mitigation measures were implemented: constructing an additional

intake as an alternative when the existing intake is blocked; increasing the number of excavators to expedite sediment removal from the channels; and constructing a second channel from the new intake to the settling basin, parallel to the existing channel, as an additional solution to mitigate downtime caused by sediment accumulation.

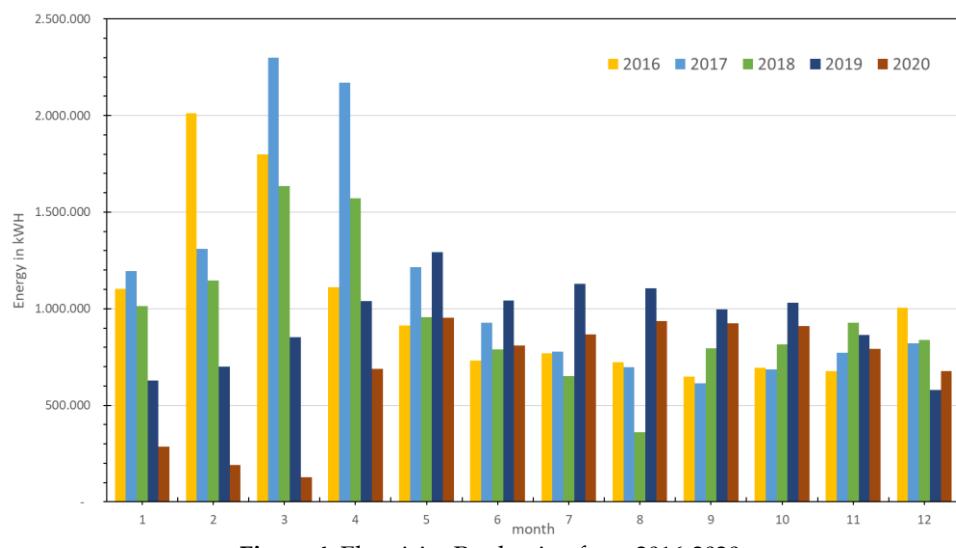
Figure 4. Electricity Production from 2016-2020

Figure 4 illustrates that the hydropower plant's productivity in July and August 2018 was lower compared to previous years. This decline stemmed from a series of earthquakes in late July and August 2018, which induced downtime and consequently reduced productivity. Following the 2018 earthquake, the plant's production graph reveals a significant shift in the production pattern for 2019 and 2020. In contrast to the pre-earthquake pattern, where production consistently increased during the wet season, the post-earthquake period exhibits a decline in production during these wetter months. This is clearly evident in December 2018, where despite the onset of the rainy season, the hydropower plant experienced a decline in production compared to November. This phenomenon contrasts with the pre-earthquake pattern, in which December consistently exhibited higher production than November. To compare production changes during the rainy season before and after the earthquake, Table 4 was created, with the average monthly pre-earthquake production calculated as the mean production for the respective month from 2016, 2017, and 2018. The average pre-earthquake production data were then compared with the corresponding monthly production in 2019 and 2020, revealing the percentage decrease in production compared to the average pre-earthquake production.
