## **Evaluation of the Sragi Secondary Channel of the Kaliwadas Irrigation Area, Pekalongan Regency**

**Abstract:** The Sragi secondary channel is located in the Kaliwadas irrigation area, Pekalongan Regency has a length of 7,587 m. The position of the channel is in a rice field area which is used to optimize irrigation to support agricultural business productivity. The existing condition of the channel in the form of native soil causes frequent leaks. Technical handling is needed to repair irrigation buildings in the form of a study on the existing condition of the Sragi secondary channel through field surveys and checking physical conditions. Furthermore, identification of the level of damage to irrigation channels is carried out. From the problems that arise at the identification stage, recommendations are then given in the form of proposals for improvements to buildings and irrigation channels. The results of the field survey in the form of network tracing provide data that the level of physical and functional damage to the Sragi secondary channel infrastructure reaches >40%. The condition is categorized as very bad with the classification of severely damaged which requires re

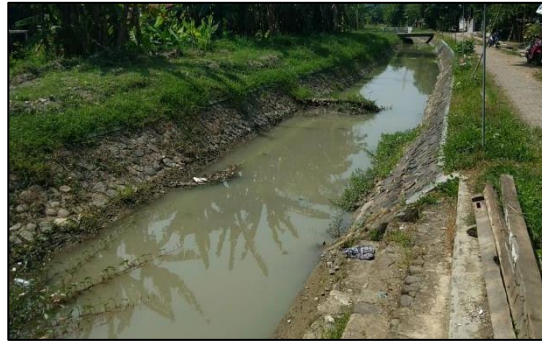
**Fig. 3.** Existing Condition Hm 50+00

| No | Location | Length (m) | Existing condition |
|---|---|---|---|
| 1 | Hm 50+00 to 50+75 | 75 | The right side lining is made of precast concrete measuring 40cm x 80cm x 0.6m with localized damages. |
| 2 | Hm 50+00 to 52+82 | 282 | The right side lining is made of stone masonry with localized damages. |

| <b>No</b> | <b>Location</b> | <b>Length (m)</b> | <b>Existing Condition</b> | <b>Recommendation for Improvements</b> |
|---|---|---|---|---|
| 1 | Hm 50+00 s.d 50+75 | 75 | Left-side stone masonry lining is damaged | Repairs with precast concrete K-300 |
| 2 | Hm 50+00 s.d 52+82 | 282 | Right-side stone masonry lining is damaged in spots | Replace damaged old stone masonry with a stone masonry 1 : 4 |

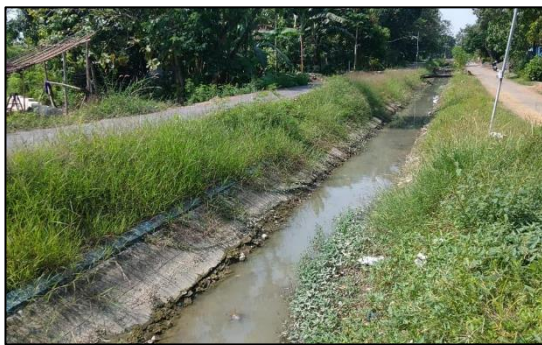
**Fig. 4.** Existing Condition Hm 58+00

| No | Location | Length (m) | Existing condition |
|---|---|---|---|
| 3 | Hm 57+57 to 60+50 | 293 | Both the right and left side linings are made of precast concrete measuring 40cm x 80cm x 0.6cm with localized damages. |

| No | Location | Length<br>(m) | Existing Condition | Recommendation for<br>Improvements |
|---|---|---|---|---|
| 5 | Hm 57+57 s.d 60+50 | 293 | Left and right precast concrete lining are damaged | Repairs with precast concrete K-300 |

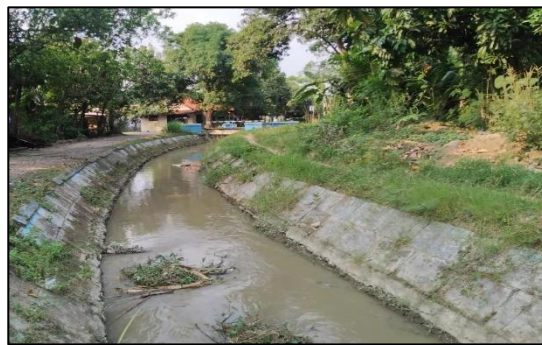
**Fig. 5.** Existing Condition Hm 71+00

| No | Location | Length (m) | Existing condition |
|---|---|---|---|
| 7 | Hm 71+00 to 75+68 | 468 | Both the right and left side linings of the existing precast concrete are still good. |

| No | Location | Length<br>(m) | Existing Condition | Recommendation for<br>Improvements |
|---|---|---|---|---|
| 11 | Hm 71+00 s.d 75+68 | 468 | Both left and right precast concrete linings are still in good condition | Maintain the old precast concrete |
