## Analysis of Factors Causing Delays in Coal Loading on the MV TAI SPRING Due to Fire in the Cargo

Awel Suryadi<sup>1</sup> ◦ Syaefulah Hidayat<sup>2</sup> ◦ Andi Prasetyawan<sup>3</sup> ◦ Iwan Kurniawan<sup>4</sup>

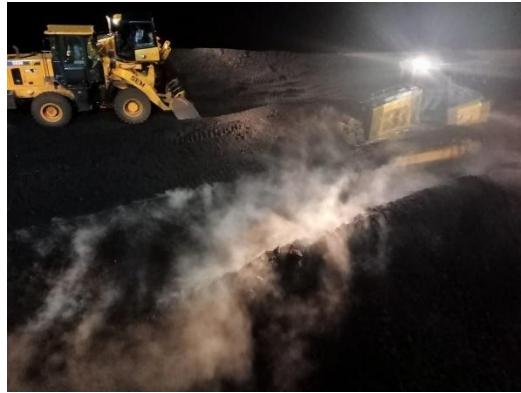
A coal cargo fire occurred on the MV TAI SPRING during loading in Muara Jawa, East Kalimantan. The fire occurred because the cargo had been at sea for too long, and the weather in the area had entered the dry season. The cargo had a high temperature and hot weather conditions, causing it to ignite and burn. Therefore, the burning cargo needed to be disposed of, and the surrounding coal also had a high risk of catching fire.

Coal loading activities on the MV Tai Spring began on March 7, 2024, at 09:15 using a ship crane. When the loading activities began, all processes of loading coal from the barge to the ship were smooth and without any obstacles or problems. The loading activities received intense attention on March 7, 2024, at 23:55 WITA when it was discovered that the coal cargo on the barge was emitting smoke, indicating that the coal cargo had a high temperature and was a sign that the cargo was burning.

Figure 1. A load of coal that emits smoke

1. Identify hazards before operation by checking the temperature of the load.
2. Inspect the area and equipment, ensuring complete PPE.
3. Use an excavator or bulldozer to open and remove any coal piles that are hot or emitting smoke.
4. Separate the burning material, spread it in a safe area, and extinguish it by pressing it with the excavator or bulldozer bucket.
5. Mix the material to eliminate air pockets and compact it to prevent the fire from rekindling.
6. Once the fire is confirmed to be extinguished, report it to the supervisor.

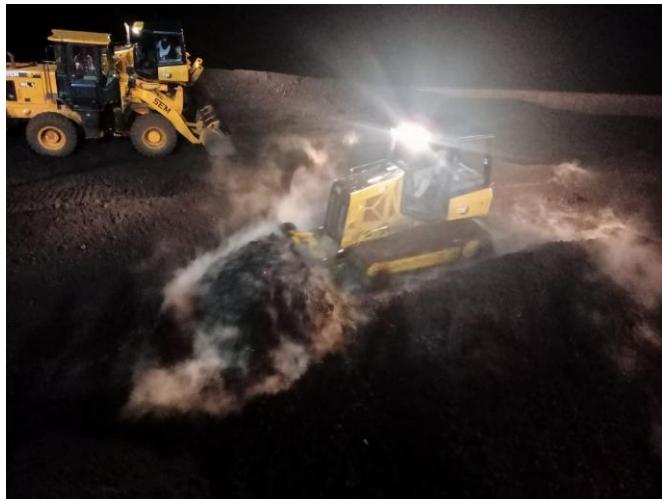
Figure 2. The process of cooling down cargo using a bulldozer

Based on the results of the temperature check, the ship's party gave instructions to carry out cooling down of the cargo using a bulldozer, considering that the ship has the responsibility to deliver the cargo to the destination port safely.

In an effort to cool down the burned cargo, the cargo owner and the ship's management halted cargo operations for 9 hours and 5 minutes, focusing on cooling the cargo. This was recorded in the agent's daily report or time sheet, from 11:55 PM on March 7, 2024, to 9:00 AM on March 8, 2024. Lack of supervision or regular temperature checks by the cargo owner. This was not fully recognized by the cargo owner because this was the first time they had experienced this.

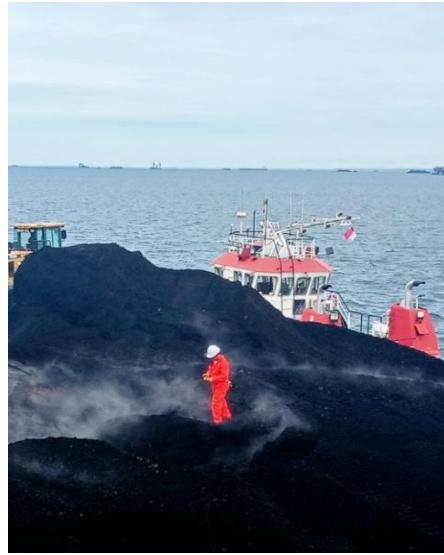
During the cargo cooling down process, the ship's crew continuously monitors and supervises the process. Every few hours during the process, the ship's crew also checks the temperature of the cargo.

Figure 3. The process of checking the cargo by the ship's crew  
Source: researcher documentation
