## INDONESIAN JOURNAL ON GEOSCIENCE

### Analysis of Lithological Aspects and Their Influence on Slope Stability of the Failed Riverbank in Ajil, Hulu Terengganu, Malaysia

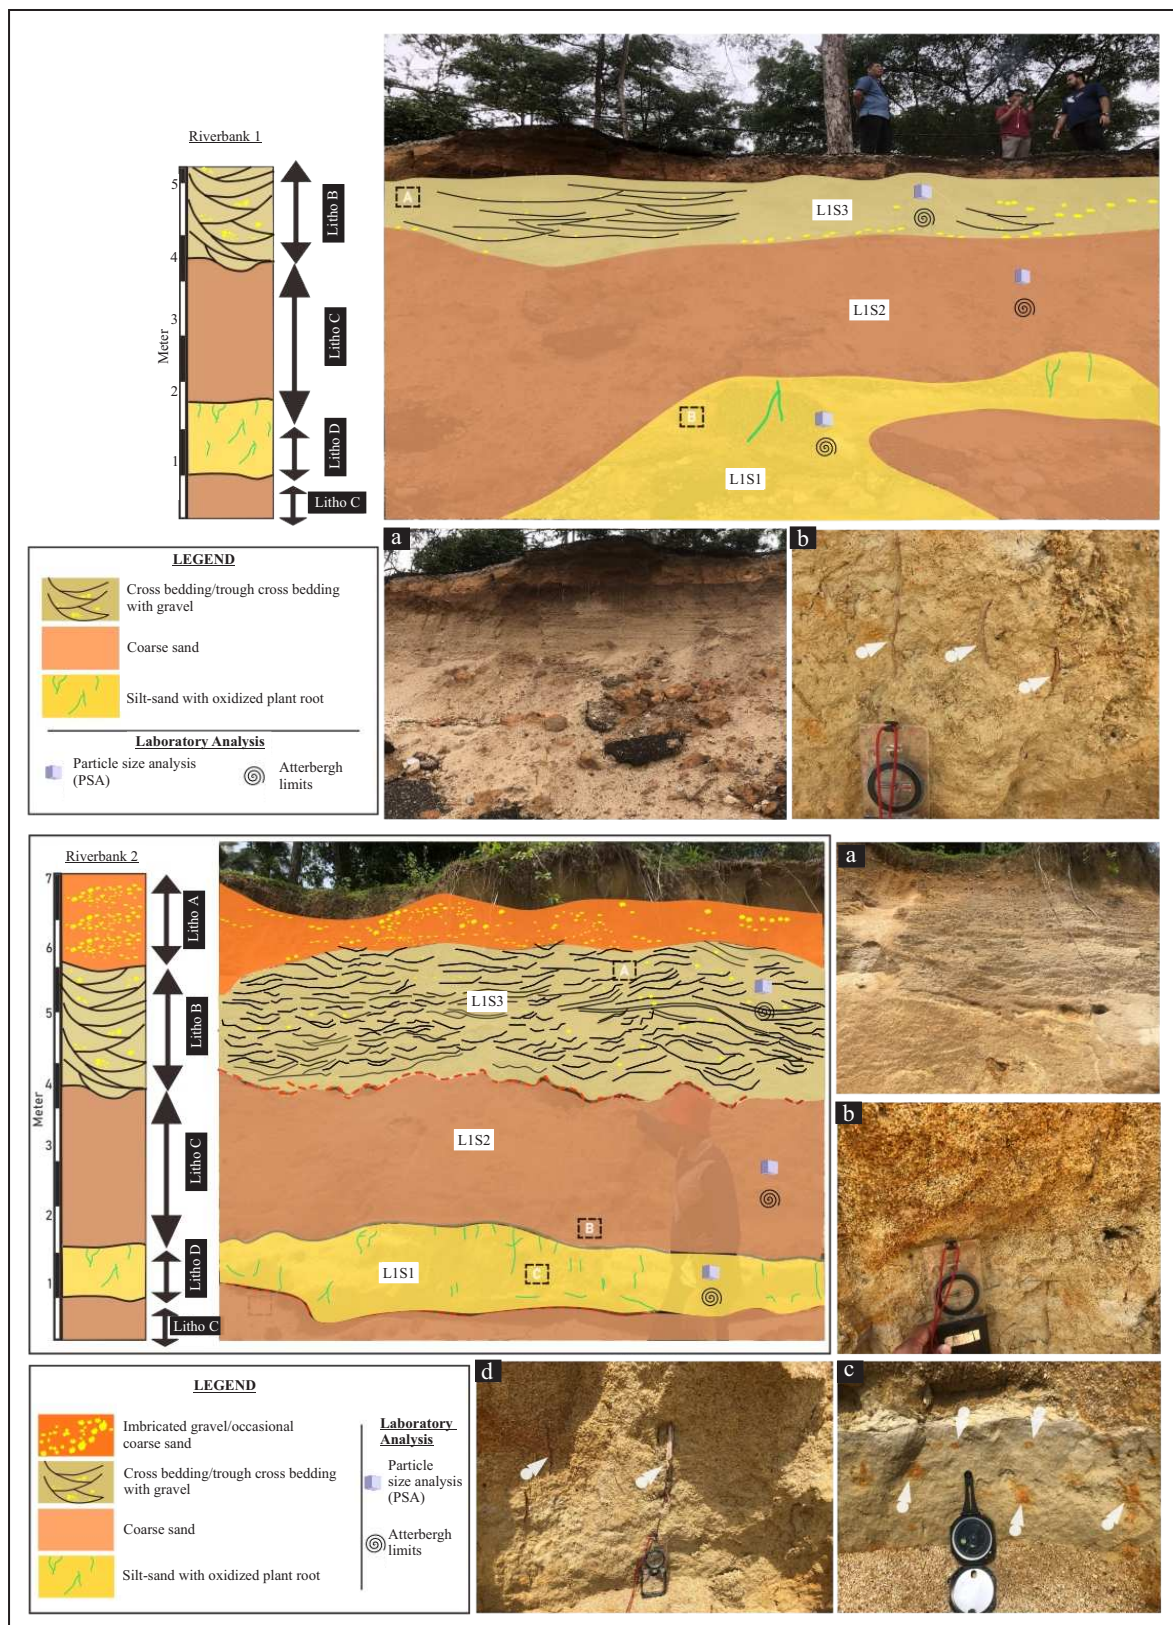
The riverbank exhibits a height of 5.2 m following a significant river overflow (Figure 2a). The logged section reveals various lithological units, which can be categorized into three main types: Litho B, Litho C, and Litho D. Litho B, approximately 1.2 m thick, is distinguished by prominent cross-bedded features. It consists of unconsolidated gravel arranged in an imbricated pattern along the upper portion of the riverbank. Samples obtained along Riverbank 1 were designated with the codes L1S1 to L1S3. Field observations indicate occasional mixing of coarse sand and silt within this area. Litho B is believed to experience high-energy processes that transport larger sediments, and produce cross-bedding features along the riverbank. Cross-bedding occurred due to the sideways and downstream movement of a channel bar, with the inclined layers being steep and slopy (Casnedi and Giulio, 1999; Saikia and Laskar, 2022). The imbrication of gravel suggests the direction of

Figure 2. a) Riverbank 1 exhibits height of 5.2 m following a significant river overflow, categorize by three main types: Litho B, Litho C, and Litho D. b) Riverbank 2, recorded at 7 m above water level and categorized to four distinct lithological units: Litho A, Litho B, Litho C, and Litho D. Note that the sample identification is located on the riverbank as L1S1–L2S3.

water flow. Litho C, situated beneath Litho B and above Litho D, varies in thickness from 1 to 2 m, and displays unsorted coarse grains. This unit is interpreted as part of the river coarse sediment deposition during periods of water overflow, particularly during floods. Litho D represents the lowest section in the logged profile with 1.1 m thick, lying below Litho C. It is characterized by its thinner nature compared to the other lithological divisions, and consists mainly of sand-silt material. Litho D shows a slightly more compact bank compared to Litho B and Litho C. The sand-silt composition suggests a decrease in water flow energy from high to low. During high-energy floods and low-energy dry seasons, the water flow varies, leading to the settlement of silt. Within Litho D, numerous oxidized plant root remnants are also present, indicating past vegetation in the area. Small plants, especially marshes and bushes, can grow along the riverbank when the sand is exposed due to low river water levels. This cycle repeats each year, leaving oxidized plant material on the sand.

This riverbank was recorded at 7 m above water level, based on the logged profile (Figure 2b). The riverbank was clearly exposed when the floodwaters receded, leaving behind the characteristic features of a modern river. The bank is divided into four distinct lithological units: Litho A, Litho B, Litho C, and Litho D. Samples obtained along Riverbank 2 are designated with the codes L2S1 to L2S3. Unlike the profile of riverbank 1, Litho A is absent, possibly eroded away during a major flood event. Litho A in the logged profile is up to 1.32 m thick, consisting of gravel and coarse-grained sand. The gravel at the lower portion of Litho A is aligned in an imbricated pattern, transitioning to a mix of scattered gravel and fine-to-coarse sand grains toward the upper part. This indicates an influx of river sediment during periods of high-water flow. Imbricated gravel can serve as strong evidence of the water flow direction in a modern river channel. Litho B, also found in riverbank

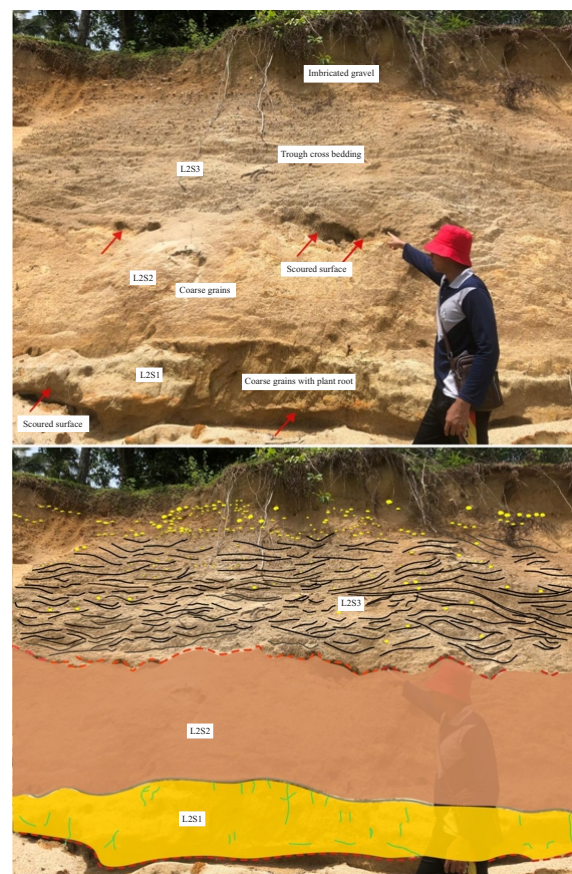
2, is thicker than in riverbank 1. It measures 1.82 m in thickness, and is characterized by cross-bedding structures, such as trough cross-bedding, with granule grains partially covering the area of the riverbank. Cross-bedding forms from the lateral and downstream movement of a channel bar, with steep, sloping layers (Casnedi and Giulio, 1999). Litho B features an erosional base, indicating river scour due to swift water flow during floods. Litho C, situated below Litho B and marked by an erosional base, ranges from 1 to 3 m in thickness. Its characteristics are similar to those of riverbank 1, consisting of unsorted coarse sand. Litho D at riverbank 2 is thinner compared to its exposure at riverbank 1, and is composed of a variety of sand and silt compositions, with a notable abundance of oxidized plant roots (Figure 3).

Figure 3. Lithology and erosional features on riverbank 2. There is trough, imbricated gravel, and scoured surface indication for high energy of water current. Note that the sample identification is located on the riverbank as L1S1–L2S3.

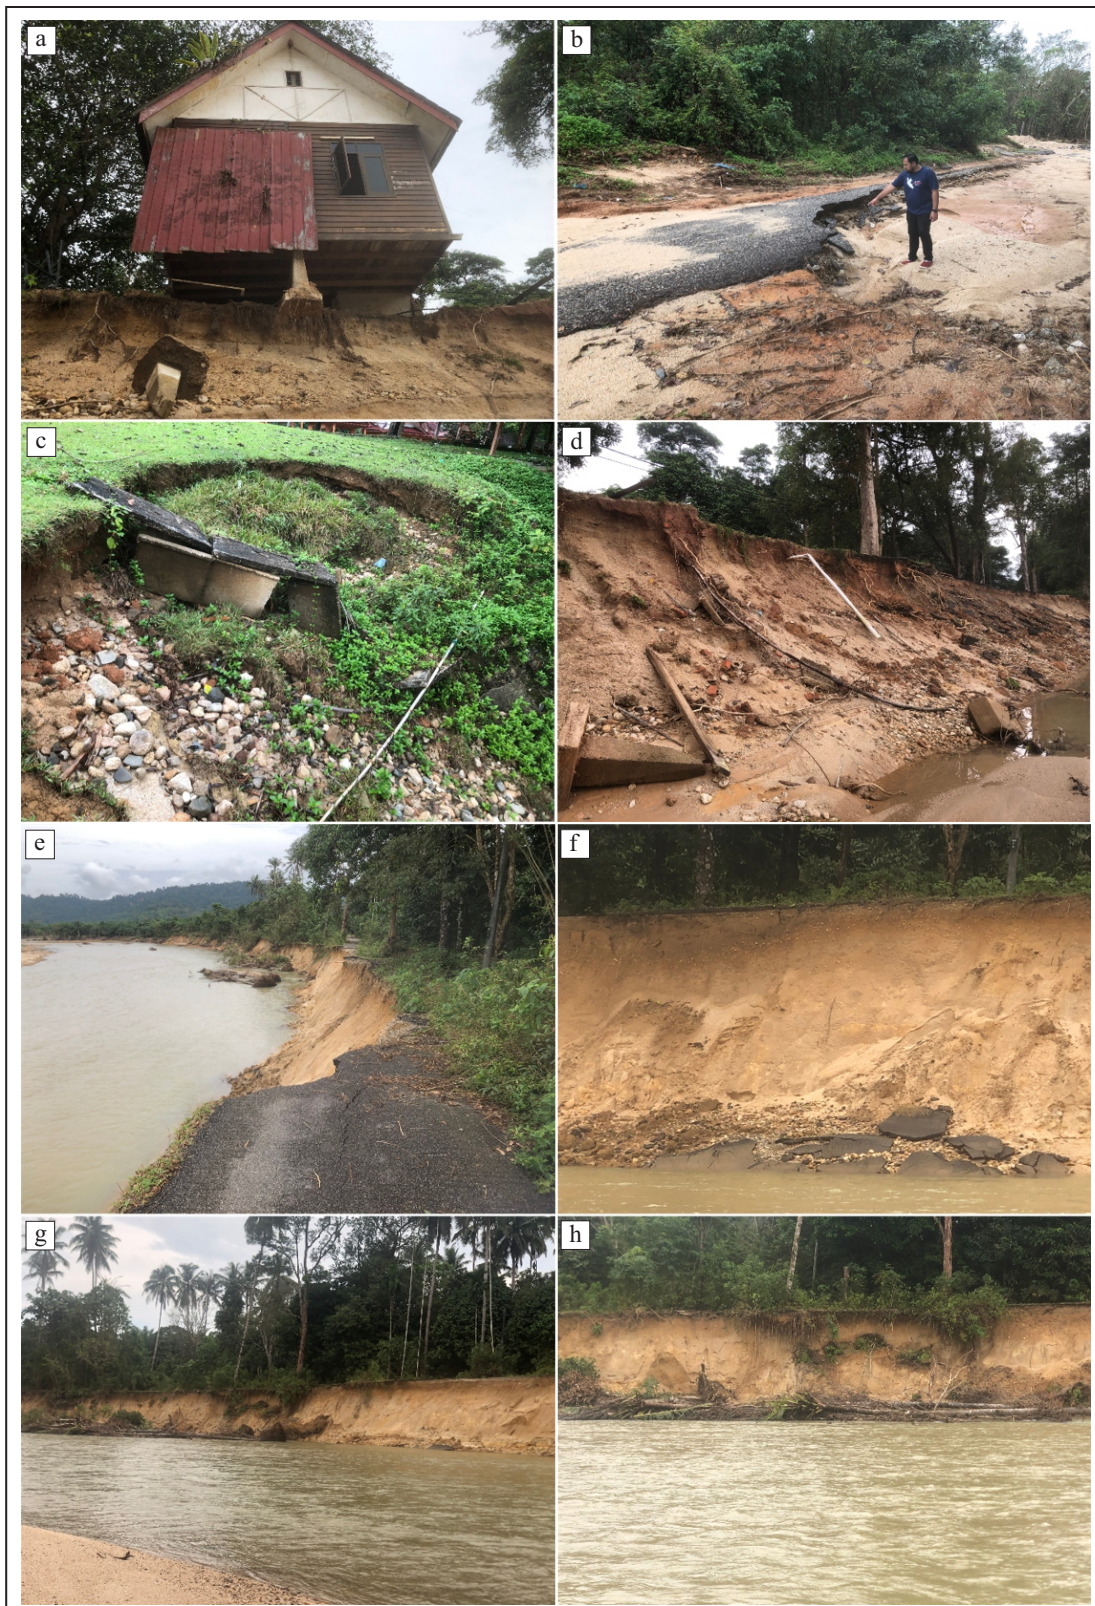
River bank erosion has been observed along the riverbank of the Belukar Bukit recreation centre (Locality 1). Erosion affects an area approximately 100 m horizontally, causing the banks, pedestrian infrastructure, trees, and built structures on the riverbanks to erode (Figures 5a and b). Furthermore, the erosion caused a small landslide scarp after the flood (Figure 5c). The height from the base to the surface of the eroded cliff reaches up to 3 m (Figure 5d). Additionally, the water has dredged up to 2 m towards the riverbank. Such severe erosion is likely to occur when the water flow is fast, and the water level surpasses the original riverbanks. This is evidenced by several uprooted trees, collapsed road and clay sediment in the riverbank toe due to affected by the water flow (Figure 6). According to Lemnitzer *et al.* (2023), the erosion mechanism of the riverbank results in wide scouring at the bottom of the steep bank, leading to landslides during high water levels. Another contributing factor is that the area of Belukar Bukit is closest to the water source, experiencing the highest pressure compared to downstream areas. Increased water velocity exerts stronger pressure on fine-sized soil types compared to river sediments such as pebbly rocks, making them more susceptible to erosion by water. Analysis of the eroded area reveals that the soil at the bottom of the cliff (*i.e.*, L2S1) consists dominantly of silt (Table 1).

The phenomenon of mass movement/riverbank failure on the sandy cliffs/slopes occurs along the riverbanks in the Belukar Bukit Village area (Locality 2). Mass movement that occurs around this river (suspect to occur during the monsoon season of December to March) shows that the banks are unstable, and are easily eroded by water currents. This is because riverbanks always experience fluvial hydraulic erosion and geotechnical instability (*i.e.* gravitational instability) processes that will lead to bank failure (Surian and Rinaldi, 2003; Islam, 2008; Zhao *et al.*, 2022; Zhou *et al.*, 2024). This two process often linked together. Fluvial erosion is the scouring of materials from bank toe by flowing water once the hydraulic force of the river exceeded the resistance threshold of the bank material, thus increasing bank angle and reduce bank stability (Langendoen and Simon 2008; Langendoen *et al.*, 2009). Sediment transport will be initiated when the shear stress overcomes bank material strength that causes the soil particles to be entrained. This happens because shear stress increases as flow increases, while bank material strength normally decreases as bank becomes saturated. This erosion leads to unstable bank, because the forces supporting the weight of the upper bank are reduced (Baracos and Lew, 2003; Lemnitzer *et al.*, 2023). Gravitational failures are frequently preceded by fluvial erosion, which is also responsible in transporting the debris created by gravitational failures. Bank sediments experience varying levels of shear stress due to differences in water pressure along the slope where sediment particles located at the bottom of the slope encounter higher hydraulic head and consequently, more stress than those located higher up the bank where the hydraulic head is lower (Staley *et al.*, 2006; Zhao *et al.*, 2022). This results in a gradient of shear stresses across the bank. The difference in shear stress also leads to the formation of a zone where the bank erodes at a faster rate, particularly at the bottom of the slope, which eventually creates steep or overhanging slopes.

The greatest erosion suggested occurred due to flowing water from the nearest dam (*i.e.* Sultan Mahmud Dam) occupy high energy will be con-

Figure 5. a) A house hanging near the riverbank due to erosion at locality 1. b) Road damage caused by water overflow during the flood at locality 1. c) A small scarp formed by a landslide on the steep riverbank after the flood at locality 1. d) Erosion occurring in the riverbank area at locality 1. e) and f) Tared road fragments at the foot of the bank due to the riverbank collapse. g) An effect of erosion on the steep riverbank, eventually causing a landslide from a different angle. h) Vegetation fell due to a landslide on the riverbank, caused by erosion at Locality 1.

sidered as a main factor for erosion. The erosion will take place on the lower part of riverbank by scouring and dredging the bank. The observation has been taken on the riverbank slide. The estimated distance of the landslide from field observations can reach more than 50 m horizontally (Figures 5e and g). The ruins of this riverside slope originally had a tarred road used by local residents. Now, fragments of the road and vegetation can still be seen on the lower riverbank (Figures 5f and h). The original distance between the riverbank and the shoulder of the road is 6 m, and when the collapse occurred, part of the road in the middle collapsed (Figure 7). The collapse of the slope occurs vertically, indicating that the slope is very steep.

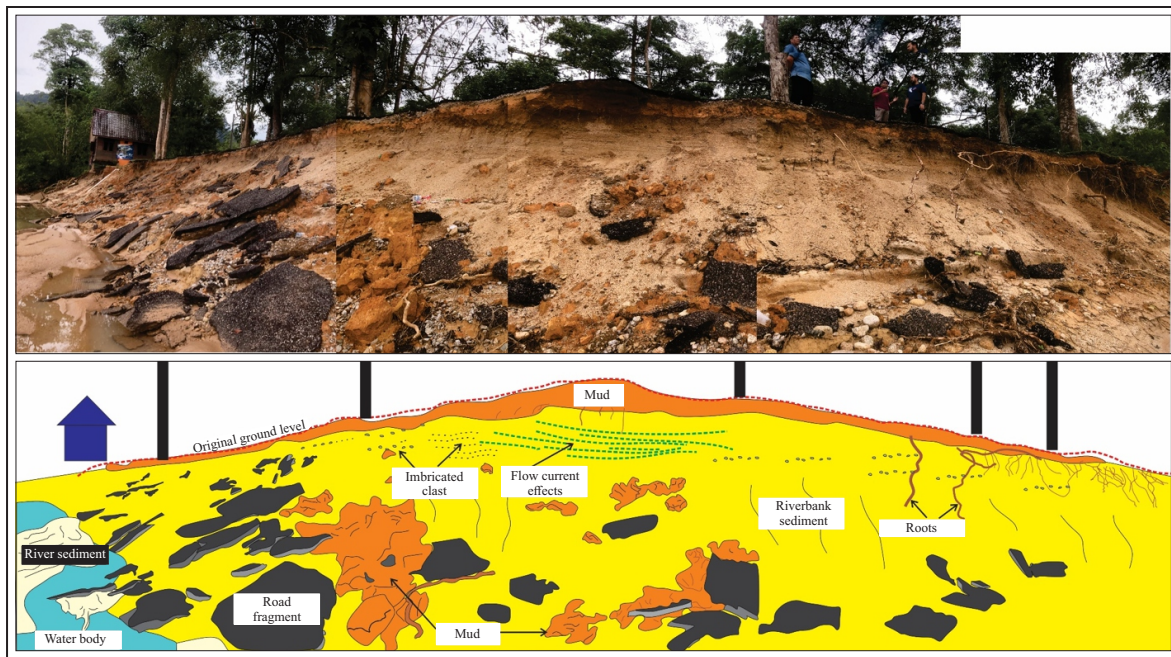
Figure 6. Anatomical sketch of erosion in the Belukar Bukit Waterfall area, Ajil after the rise in water level and also the rapid water current. Clearly observed the effect of waterways through the arrangement of imbrication of pebbles on the riverbanks. Clay sediment as well as broken roads can be seen in the lower part of the river.

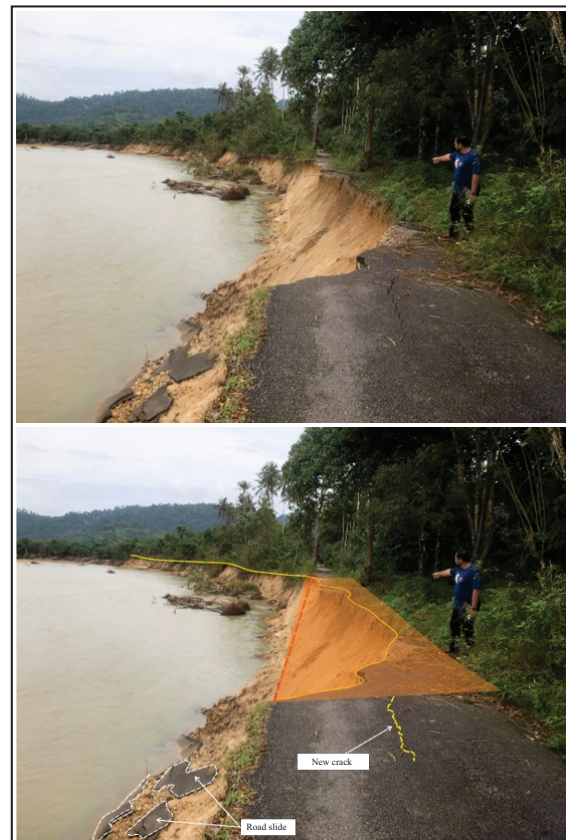
Figure 7. Sketched area of the broken road due to the occurrence of a landslide, also clearly observed the breakdown of the tar road at the bottom of the slope.

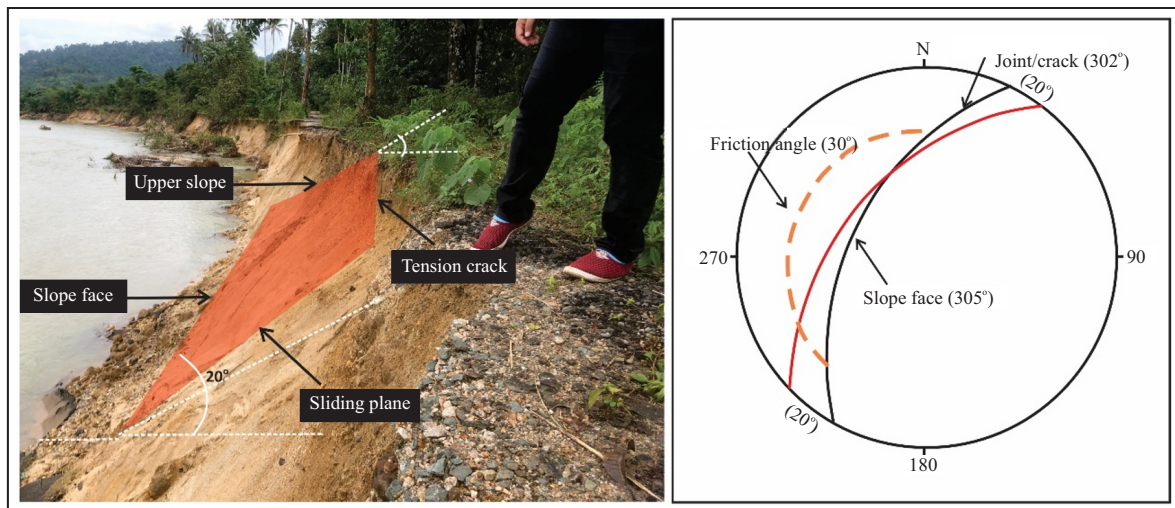
Slope measurements (dips) were recorded in the studied area with relatively high slope values of  $60^\circ$  to  $70^\circ$  and a slope direction of  $305^\circ$ . Using the friction angle,  $\Phi$ , of  $31^\circ$ , a simple kinematic model has been made using a stereonet to determine the type of failure (Figure 8). When a flood recedes, the planar type of riverbanks is usually affected by significant erosion due to several factors. These include; (1) the reduction of the hydrostatic

Figure 8. A field observation analysis of the steep river slope in Sungai Berang at locality 2. A geometric sketch was drawn for the purpose of making it easier to observe mass movement on the river slope. Next to the picture is a geometric sketch showing a kinematic model that is analyzed as a planar failure of the soil due to the sliding plane (friction angle) < the crack (sliding surface angle) < the slope face angle (slope face angle) and the crack plane is parallel to the slope face.

force/pressure caused by the decrease in the water level (Pasha *et al.*, 2025; Eskandarinejad *et al.*, 2025), (2) the time delay between the lowering of the water level in the river and the underground water level which generates a significant uplift force (Wang *et al.*, 2020; Ren *et al.*, 2022), and (3) the decrease in suction force and apparent cohesion caused by the infiltration of rainwater or groundwater seepage (Rinaldi and Casagli, 1999). When a slope is steep, the failure is likely to happen on a smooth and level surface where the block slides into the channel without any rotation.
