Analysis of Air Induction System Testing on the 2011 Daihatsu Xenia Type Xi

Bahtiar Wilantara

Department of Automotive Engines, Politeknik Piksi Ganesha Indonesia, Indonesia, 54311

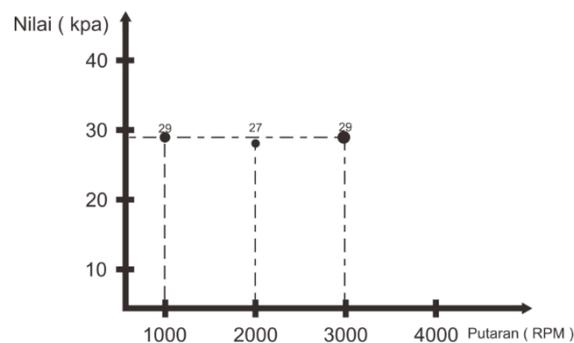
Figure 4. Graph of Checking the MAP Sensor at Several RPMs

In **Figure 4**, it can be concluded that the MAP sensor value decreased at RPM 2000 by 2 kPa to 27 kPa and increased at RPM 3000 by 2 kPa to 29 kPa. After using the scan tool, the MAP sensor voltage is measured using a multimeter. The results of measurements using a multimeter are presented in Table 1.

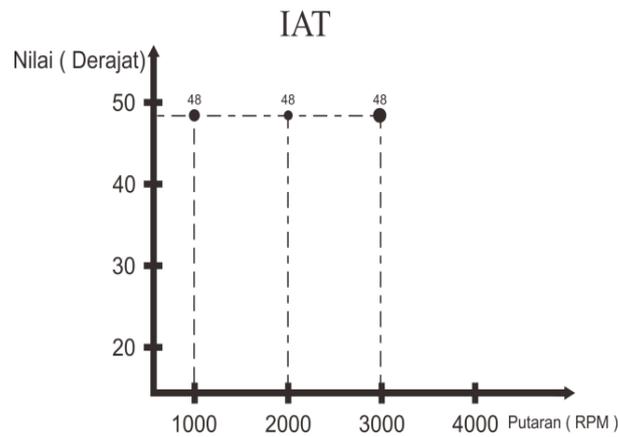
Figure 5. Graph of IAT Sensor Checks at Several RPMs

In Figure 5, it can be concluded that the IAT sensor has not decreased and increased at 1000, 2000, and 3000 RPM rotation of 48. After using a scan tool, the IAT sensor voltage is measured using a multimeter. The results of measurements using a multimeter are presented in Table 2.

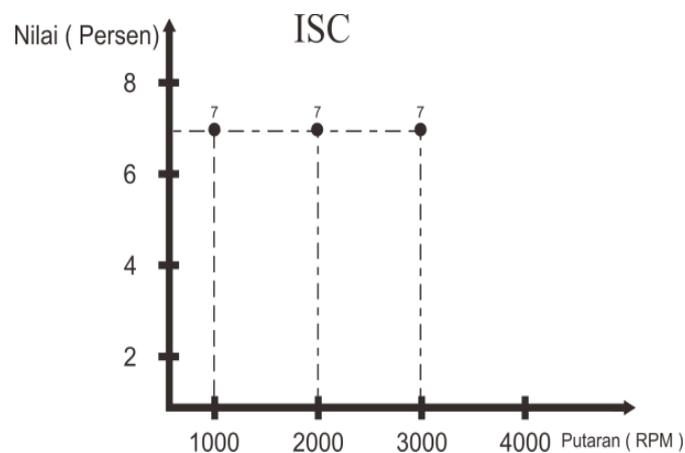
Figure 6. Graph of ISC Examination

In Figure 6, it can be concluded that the ISC did not change either at 1000, 2000 and 3000 RPM rounds of 6.99%. After using the scan tool, the ISC voltage is measured using a multimeter. The results of measurements using a multimeter are presented in **Table 3**.
