ANALYSIS OF EXHAUST VOLUME REDUCTION IN OILY WATER SEPARATOR AT SS. GOLDEN ISAIA

Muhammad Daffa¹, Andy Wahyu Hermanto^{2*}, Kresno Yuntoro³

^{1,2,3} Semarang Maritime Polytechnic

(Received: 13-08-2024; Reviewed: 29-08-2024; Revised: 23-10-2024; Accepted: 16-11-2024; Published: 29-11-2024)

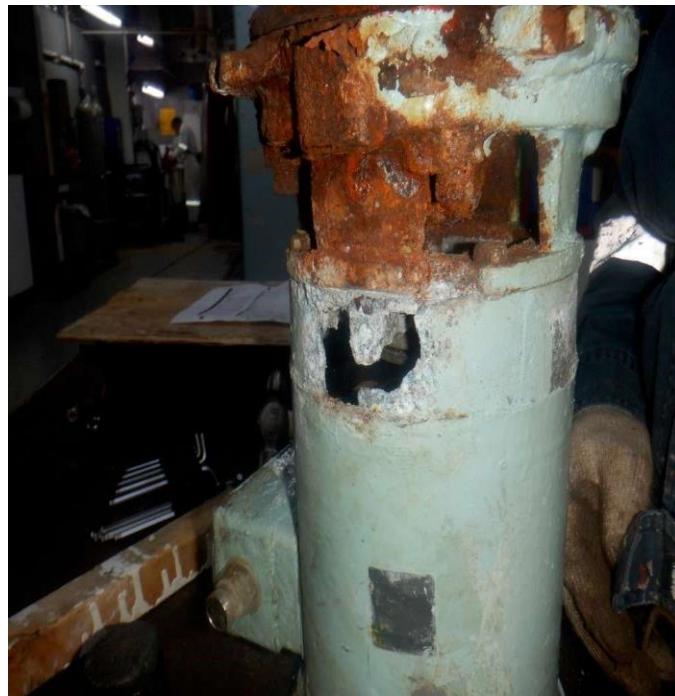
Figure 3 Condition of the feed pump oily water separator
Source: Research Documentation

After a visual check, it was found that the physical condition of the pump had been eaten away by corrosion, and when the pump was opened the impeller condition had also been eaten away by corrosion and was very difficult to remove from its shaft, as well as its bearing. This caused the feed pump pressure to be low and not operating at the working pressure according to the manual.

- a. Factors causing the decrease in discharge volume in the oily water separator at SS. Golden Isaia
 - 1) Damage to the OWS feed pump due to corrosion
Corrosion on the feed pump can be caused by high humidity in the air around the oily water separator. If this is left unchecked, corrosion will spread further to the oily water separator components.

To handle the feed pump that has been corroded, initially the crew wanted to replace several pump components that were no longer feasible. However, this was not possible, because the components were stuck due to corrosion, and the pump casing was also mostly corroded. After checking the spare part room, a set of feed pump oily water separator along with its electric motor was available (Sulaiman & Suharto, 2020), so the effort to overcome the decrease in exhaust volume in the oily water separator at SS. Golden Isaia was to replace a set of OWS feed pump along with its electric motor showed in in Figure 6.

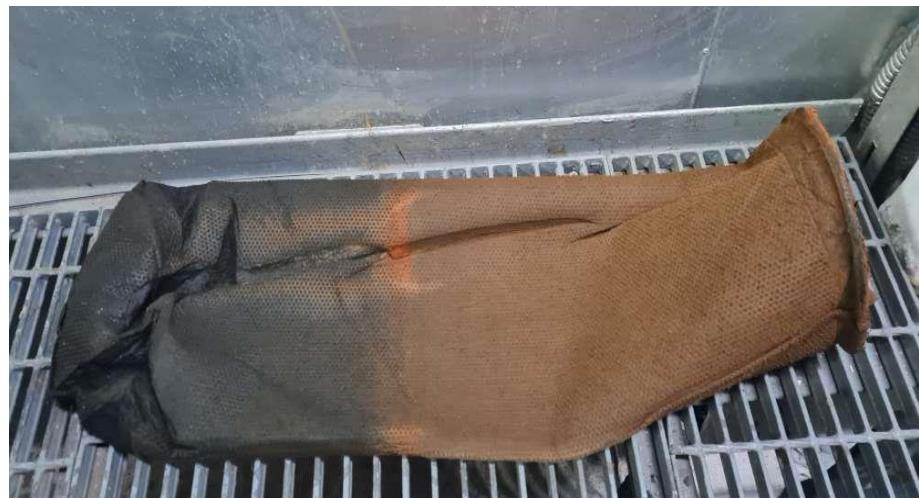
Material factors that cause a decrease in exhaust volume in OWS at SS. Golden Isaia are coarse particles in the bilge tank causing the OWS process filter to become increasingly clogged. Dirty process filters can also be one of the findings that cause a decrease in exhaust volume in the oily water separator. This can be indicated by the differential pressure gauge indicator which shows the difference in pressure before and after passing through the process filter. According to the manual book, the filter bag must be replaced when the pressure reaches 1 bar. When observed, the differential pressure had reached 1.2 bar showed in Figure 4.

Figure 4 Filter Bag in the oily water separator filter process

- 2) Dirty process filter
Dirty process filters in oily water separators can also affect the flow of water that will be discharged into the sea by oily water separators. A dirty process filter is caused by the accumulation of coarse particles from the bilge tank.

Based on data collected from observations, interviews, and literature studies, efforts to overcome the cause of dirt accumulation in the bilge tank process filter are to clean the strainer and replace the filter bag. This is done based on the manual book instructions (Ardhi et al., 2018). Inside the strainer of the process filter there is a filter bag as a double filter. The instructions in the manual book state that the filter bag must be replaced if the pressure differential before and after the process filter reaches a pressure of 1 bar showed in Figure 7

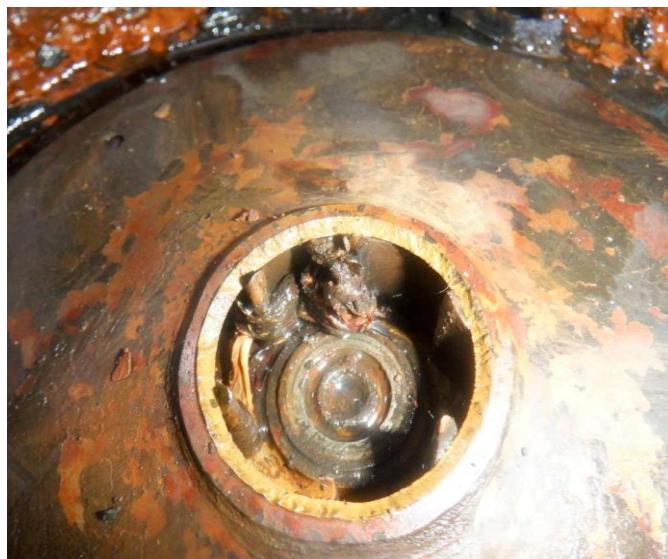
Figure 5*feed pump* components affected by corrosion.
Source: Research Document

- 1) Replacing a new set of OWS feed pumps showed in Figure 5

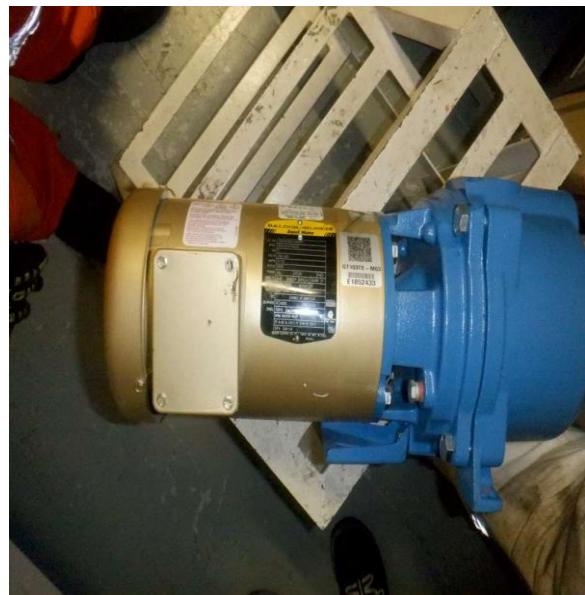
Figure 6 One set of OWS feed pumps
Source: Research Document

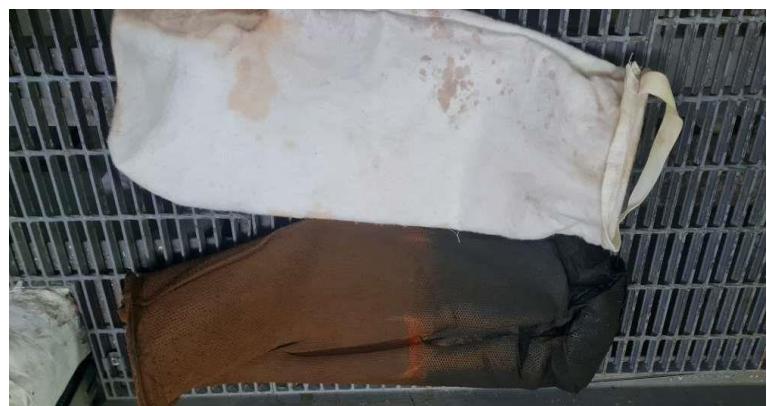
Figure 7. Replacement of OWS filter bag
Source: Research Document

2) Cleaning the strainer and replacing the filter bag
