# Advanced Failure Analysis of Hydraulic Systems in Volvo Articulated Haulers at Coal Mining Sites: Investigating Steering Cylinder Seal Failure and Brake Accumulator Degradation

The condition of hydraulic systems is critical to the productivity and safety of heavy equipment in coal mining operations. This study analyzes Hydraulic Systems in Volvo Articulated Haulers at coal mining sites in South Sumatra, Indonesia. Progressive failure of the steering cylinder seal on a Volvo ART A40F, manifested as hydraulic oil leakage and a drop in measured steering pressure from the standard 250 bar to 203 bar; and degradation of the brake accumulator unit on a Volvo ART A40G, causing a low brake pressure warning and a drop in pressure from the normal range of 145-245 bar to 118 bar. Both failures were caused by wear-induced mechanisms exacerbated by the harsh mining environment fine particle contamination, high thermal cycling, and continuous duty cycles. For the A40F, post-repair inspection revealed that the scraper / dust seal had thinned from 7.8 mm (new) to 6.1 mm, allowing the ingress of particles that accelerated piston rod seal wear. For the A40G, three of the seven accumulators had lo

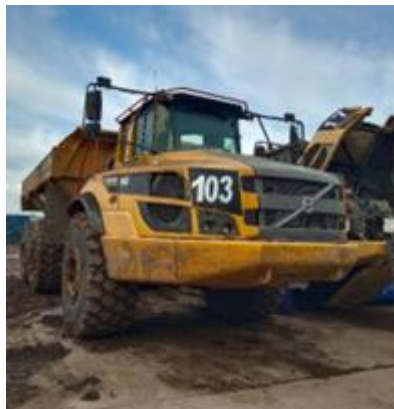
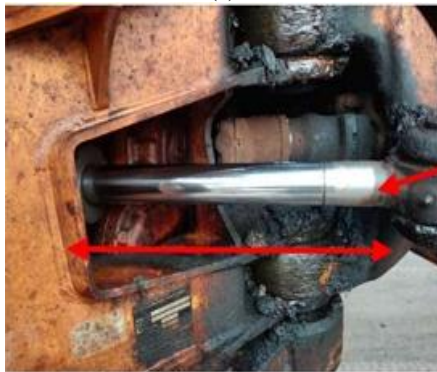
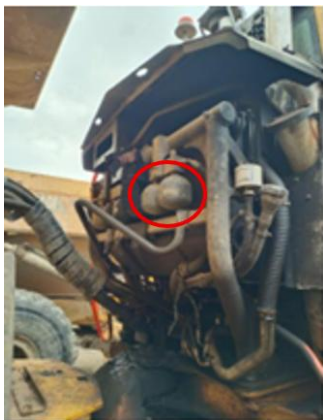
**Figure 1.** Volvo Articulated Hauler a). A40F (SN 11001-99999), b). Steering Cylinder Seal, c). Brake Accumulator

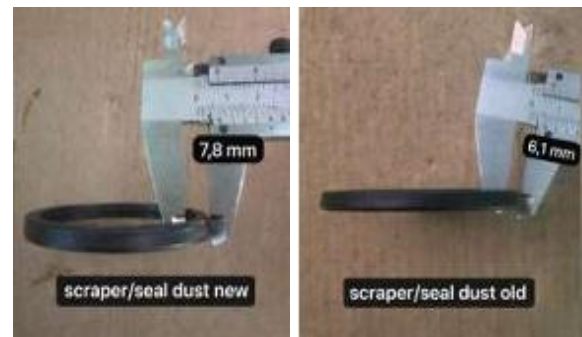
The most significant finding was observed on the scraper component. Measurement showed that the scraper thickness had decreased from 7.8 mm to 6.1 mm, representing a 22% reduction in material, shown in the Figure 6. Since the scraper functions

to remove dust and particles from the piston rod surface before entering the cylinder, this reduction weakened its sealing effectiveness and allowed fine contaminants from the mining environment to enter the seal area, accelerating wear and leakage [18], [25].

**Figure 6.** Comparison Scraper/Seal Dust, a). New, b). Old

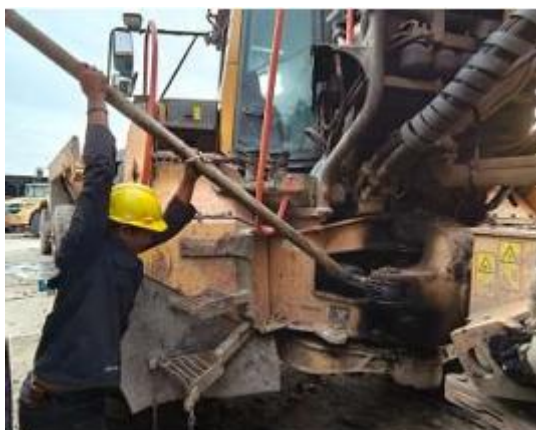
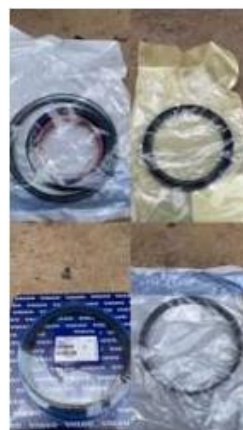
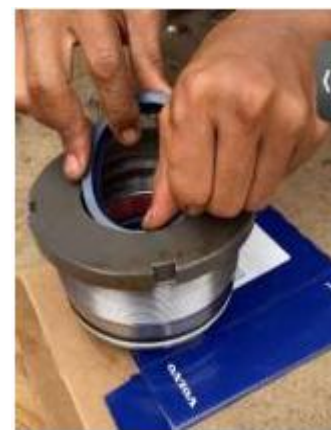
**Figure 7.** Repair Volvo Articulated Hauler a). Piston Rod Guide, b). Scraper/Seal Dust, c). Installation

Investigation based on pressure testing showed that the steering system operated at only 203 bar at full steering lock and 1200 rpm, which was below the Volvo standard specification of  $250 \pm 4$  bar and In addition, the hydraulic oil level in the reservoir was measured at around 203 liters compared to the standard capacity of 245 liters. investigation based on Standard Specification Volvo A40F SN 11001-99999, shows the need for component improvements based on research data on scraper / seal dust which has experienced a reduction in dimensions from standard size of 7.8 mm. Scraper / seal dust repair is shown in the Figure 7, and the comparative measurement results are shown in the graphic Figure 8.
