## OPTIMIZATION OF COMPRESSOR PERFORMANCE ON THE SHIP KM. PUSRI INDONESIA

The KM. Pusri Indonesia is a bulk carrier owned by PT. Pupuk Indonesia Logistik, specifically designed to distribute fertilizer from producers to various locations throughout Indonesia. Based on the survey results, this study aims to identify factors causing performance decline and implement optimization measures for the compressor. Air compressors play a vital role in providing pressurized air to various ship machinery systems, so decreased performance can hamper operations.

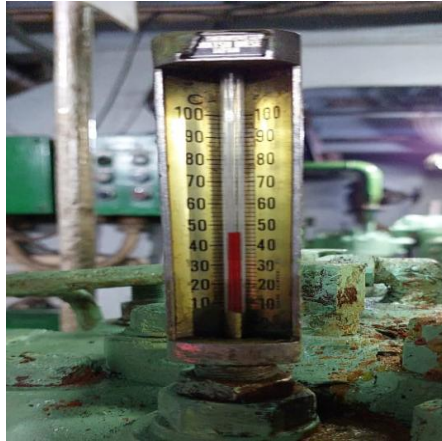
1) Leak in the cooling pipe

The function of the compressor cooling system is to maintain the ideal operating temperature of the compressor, thus preventing overheating, maintaining optimal engine performance, and extending the life of the compressor components. If a leak occurs in the cooling pipe, cooling efficiency will be compromised, ultimately triggering a series of problems. Some indicators that can indicate a leak in the cooling pipe are corrosion and wear due to vibration. Corrosion can be seen in the cooling pipe due to dirt, mud, or scale adhering to it.

Leaks in the cooling system are a serious problem that directly impacts compressor performance, primarily because they gradually cause overheating. Because heat cannot be absorbed properly, the air temperature inside the compressor cylinder increases dramatically. As a result, the compressor must work harder to compress the hot, lower-density air. This increased workload further exacerbates the temperature rise. Overheating is not simply a high temperature, but a condition where the operating temperature exceeds the safe limits set by the instruction manual. Upon observation, the output temperature on the thermometer reached 46°C. This indicates the compressor is experiencing trouble, with the coolant supply temperature around 32°C and the output temperature around 40°C during operation.

Figure 3.1 The Compressor Cooler is experiencing overheating

a. Welding on leaking coolant pipe

Once you discover a leak in the coolant piping, the first step in optimization is to inspect and repair the leak. Perform regular visual inspections and pressure tests on all coolant piping lines, including connections and hoses. Any leaks, no matter how small, should be repaired immediately by welding or even replacing the component.

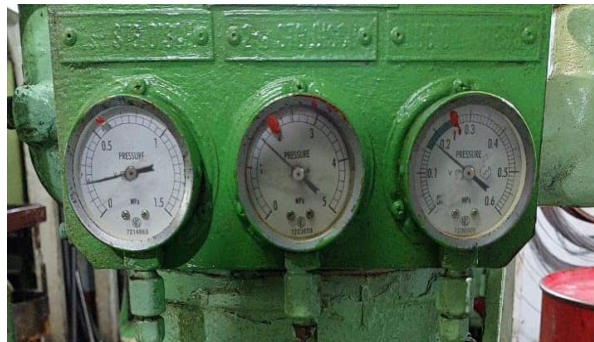
2) Crust or dirt on the valve

Scale on valves, especially low-pressure and high-pressure valves, is a buildup of dirt that can interfere with valve performance, reduce efficiency, and even cause leaks. Air particles contaminated with dust and oil will adhere to the valve and eventually form scale. Furthermore, without regular cleaning, the scale that begins to build up won't be removed and will continue to thicken, reducing valve performance and even causing it to seize.

Scale on the valve directly causes internal leaks, which leads to a decrease in air pressure at each compression stage (first and second stages). As a result, the air pressure in the first and second stages cannot rise and maintain the required pressure. Furthermore, this condition can trigger overheating, which causes a decrease in lube oil pressure. All of these indicators indicate a problem with the compressor's efficiency.

Figure 3.2 Compressor pressure gauge decreases

b. Cleaning scale or dirt on the valve

In subsequent inspections, maintenance was performed on the low- and high-pressure valves to improve compressor performance. If a valve malfunctions, it can result in an inability to close properly, resulting in insufficient air flow to the air tank. The primary cause is scale or dirt adhering to the low- and high-pressure valves. To resolve this issue, the valves must be cleaned using a brush, sandpaper, or soaked in diesel fuel for approximately 15 minutes to remove the scale or dirt.
