# Seismic Performance Evaluation of An Interior Reinforced Concrete Beam-Column Joint Subjected to Cyclic Loading

Chandra, J.<sup>1\*</sup>, Wibowo, H.<sup>2</sup>, Christian, Y.B.<sup>1</sup>, Handoko, J.<sup>1</sup>, Gunawan, A.<sup>1</sup>, and Ardenlie, F.G.<sup>1</sup>

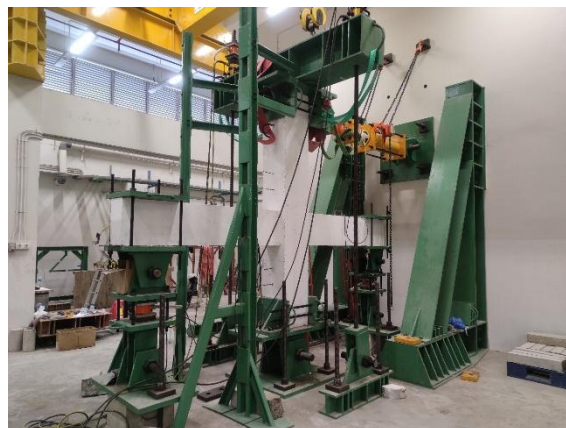
**Figure 2.** Overall Test Setup of the RC Beam-column Joint Specimen

The specimen was restrained with pin support at the bottom of the column and the beams were restrained for vertical movement at the inflection points (see Figure 2). Cyclic lateral force was generated by a double-acting hydraulic cylinder attached to the top of the column. In addition, vertical hydraulic cylinders and spreader beam were used to apply axial force to the column. There was a total of five load cells (LC) used in the experiment. LC1 was placed in front of the lateral hydraulic cylinder to measure the generated lateral load, while LC2 and LC3 were placed above the vertical hydraulic cylinders to measure the generated axial load. LC4 and LC5 were placed below the beams to measure their vertical reactions.

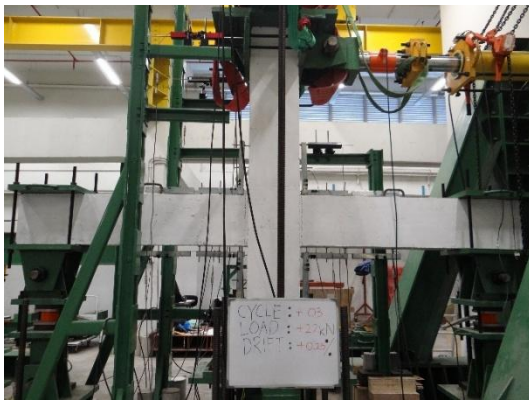
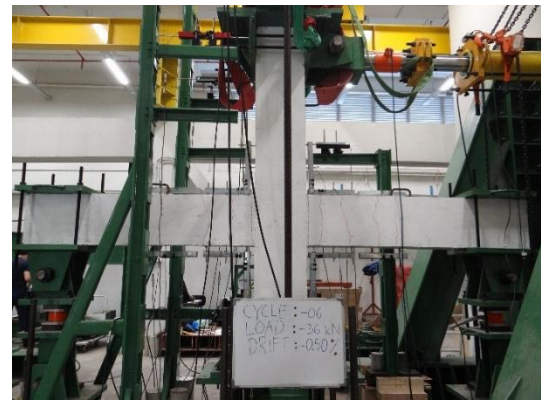
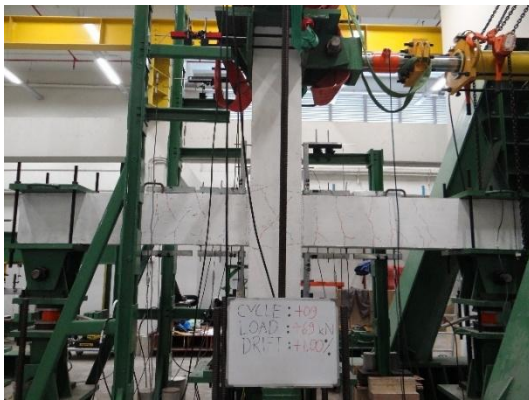
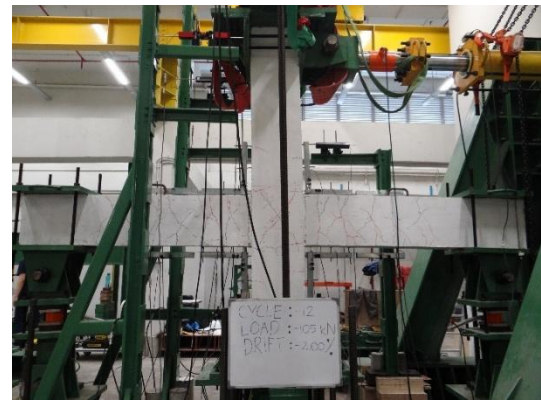
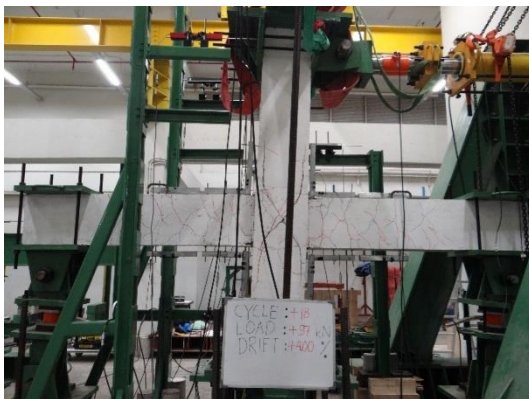
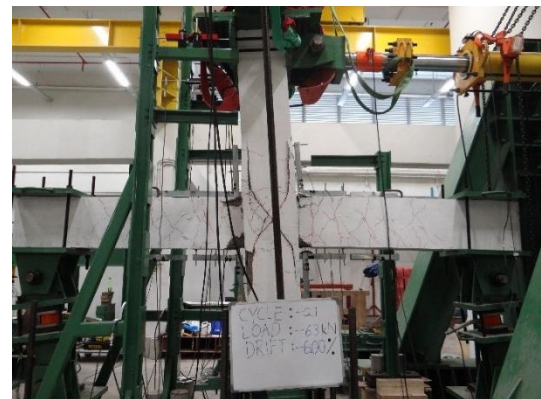
Cycle No. +03; +0.25%; +22 kN

Cycle No. -06; -0.50%; -36 kN

Cycle No. +09; +1.00%; +69 kN

Cycle No. -12; -2.00%; -105 kN

Cycle No. +18; +4.00%; +97 kN

Cycle No. -21; -6.00%; -63 kN

**Figure 9.** Crack Patterns Propagation of the RC beam-column Joint Specimen during Testing. Note: +18; +4.00%; +97 kN indicates the eighteenth cycle in positive direction, drift ratio, and lateral force at the respective drift ratio. Positive direction is from left to right

The crack patterns propagation is shown in Figure 9. The first numbers represent cycle numbers in the positive or negative directions. The second and third notations denote respective drift ratios and lateral forces. In the beginning of testing until 0.50% drift, flexural cracks only appeared at the beams. As the drift increased, the number of cracks in beams also increased. Moreover, at 1.00% drift, some flexural cracks were also observed in columns and there were diagonal cracks in the joint. These major diagonal cracks became more apparent at 4.00% drift. At the end of the testing, i.e. 6.00% drift, crushing of the compression zone at the beam ends were spotted and there were spalling of cover concrete at columns near major diagonal cracks.
