## Modification of The Oil Cooler to Avoid Oil Leaking in Generator Transformer PLTU Labuan “Moderator”\*

The Main Generator Transformer for PLTU Labuan is a transformer with a power capacity of 350 MVA and a cooling system of 6 pcs OFAF (Oil Force Air Force) type. During operation, a disturbance to the Main Generator Transformer (GT) was caused by an oil cooler leak. This is caused by the corrosive expand tube caused by the constituent material consisting of 2 different types of materials. The oil leak caused environmental pollution, decreased oil level, and increased winding temperature and oil temperature on GT. During the decade of operation of the PLTU Labuan, GT oil cooler leaks almost always occur every year, both in unit 1 and unit 2. To anticipate this, we made modifications to the end tube design by changing the type of material on the expanded tube from initially using iron to aluminum such as tube material outside the expanded position. The next design change is to increase the length of the end tube which is equipped with the knock and glue with an expansion strength above normal operating temperature which makes the end tube more reliable by increasing the surface ar

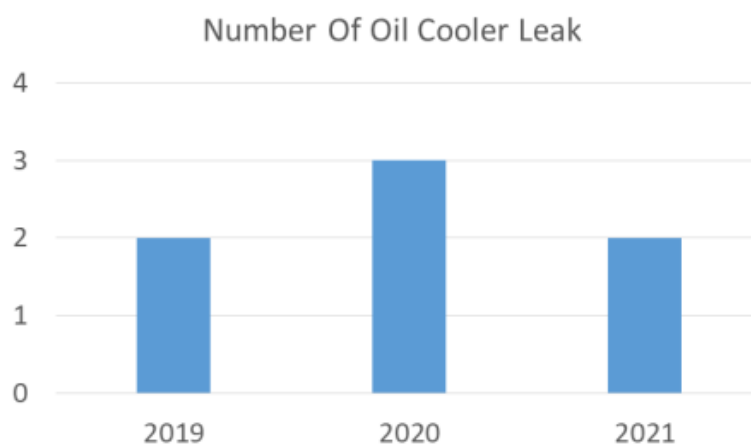
Figure 2. Oil Cooler Leakage Data 2019-2021

Based on data on the number of oil cooler leaks in the last 3 years, they are as follows:

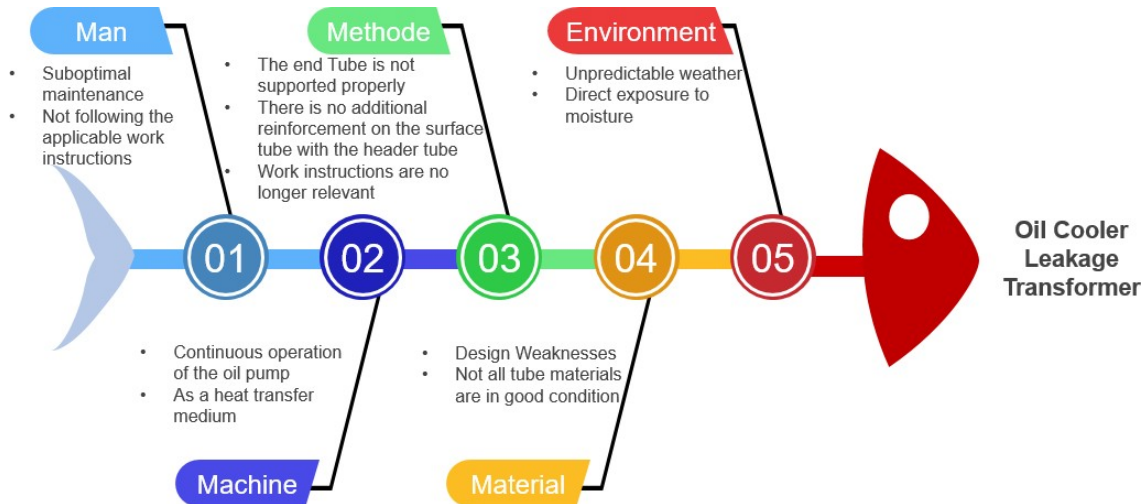
Figure 4. Fishbone Diagram RCFA

An overview of the background and root causes of oil leakage in the transformer oil cooler is described in the following Fishbone Diagram RCFA analysis:

The root of the problem of oil leakage in the tube Oil Cooler transformer refers to the Material and Method factors. On the material factor, the tube oil cooler consists of 2 different materials, namely aluminum on the tube and for the expand tube using iron, so that it becomes one of the weaknesses that causes corrosion (Xi'an Xibian Components, 2008). Corrosion that occurs due to the presence of 2 different metals in one electrolyte so that the more anodic metal will be corroded, including the type of Galvaniscorrosion (Utomo, 2009). In addition, because the tube oil cooler works at varying working temperatures, if there is an expansion, then the tube consisting of 2 different materials will result in internal stress which has an impact on disturbances in the oil cooler. From this, if the tube is corroded due to material differences, there will be a decrease in the function of the equipment, resulting in leakage.

In Factor Method, based on a field study, it was found that the leak of the Oil Cooler tube came from the upper side of the end tube where at that point the existing Oil Cooler was not strong enough in the buffer system to the header tube. So if there is corrosive on the end tube and there is no strong support, of course the oil distribution process cannot run according to its proper function, because it causes the end tube position to not accommodate the entire flow of oil used as a transformer winding cooler.
