AN INVESTIGATION OF FREQUENCY SPECTRUM ANALYSIS FOR THE DETECTION OF BEARING DAMAGE IN CENTRIFUGAL PUMP UNIT 731PU1205 F2

Nota Effiandi¹, Muhammad Satria Efendi Syahra², Muh. Anhar³, Yuliarman⁴, Yuli Yetri^{5*}
Departement of Mechanical Engineering, Padang State Polytechnic^{1,2,4,5}
Departement of Mechanical Engineering, Ketapang State Polytechnic³
Email : yuliyetri@pnp.ac.id*

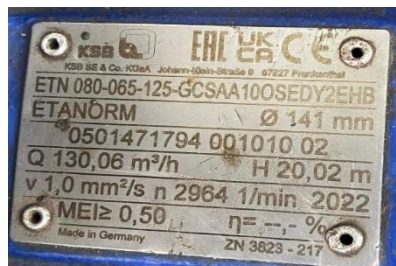
Figure 1. Specification of centrifugal pump bearings

- a. Bore Diameter (in) : 25 mm
- b. Outer Diameter (out) : 62 mm
- c. Bearing Width : 17 mm
- d. Number of Balls : 9 Pieces
- e. Ball Diameter : 9 mm
- f. Pitch Diameter : 43 mm
- g. Rotation Speed (RPM) : 2964

The bearing specifications above are obtained from the specification of the centrifugal pump can be seen in Figure 1
