Diagnostic Approach and Troubleshooting of Low Power Hoist Dump System in Komatsu HD 785-7

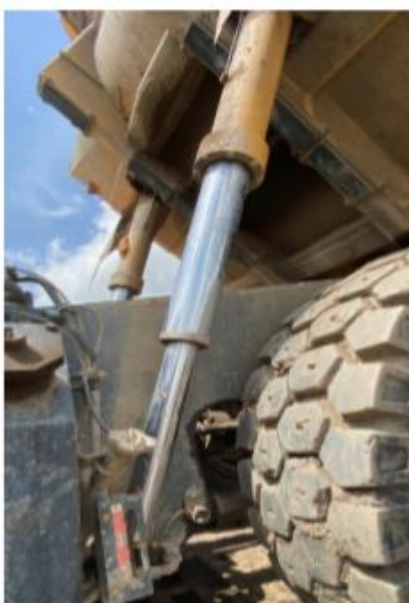
Figure 1. Hoist Cylinder

The hoist cylinder on the dump body of the Komatsu HD785-7 unit is a vital component that functions to raise and lower the dump body during the loading and unloading process [9]. This system consists of several hydraulic cylinders designed to withstand heavy loads and operate under extreme conditions in mining environments, as shown in Figure 1.

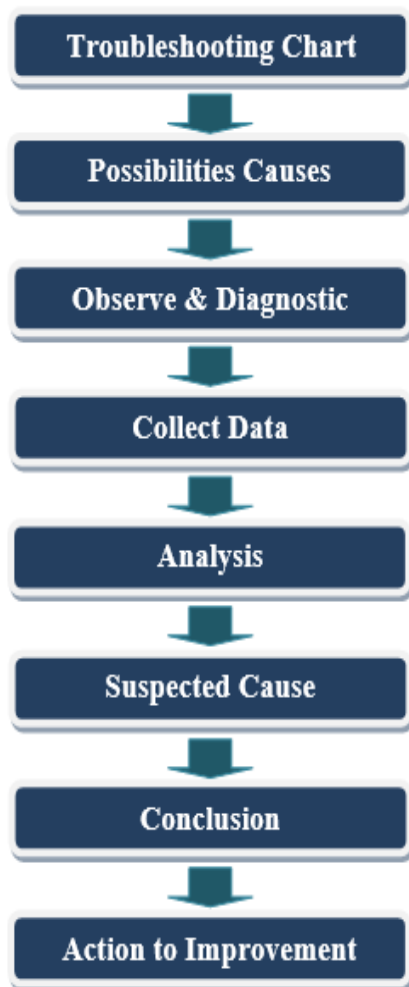
Figure 2. Flow Chart for 8 Step Troubleshooting

The process begins with referencing the manufacturer's troubleshooting chart, which maps common operational symptoms to potential component-level issues. From this initial review, a list of possible causes is formulated, focusing on both mechanical and electrohydraulic subsystems. The procedure then moves into the observational and diagnostic phase, where system behavior is assessed through visual inspection, performance evaluation, and control input testing [21].

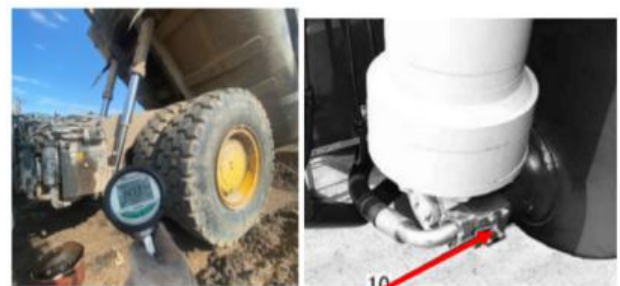
Figure 3. Oil Cylinder Pressure Measurement

The pressure at the hoist system relief line was measured using a calibrated digital hydraulic pressure gauge. As illustrated in Fig. 2, the measured pressure was 147 kg/cm^2 , significantly below the standard range of $185\text{--}195 \text{ kg/cm}^2$ as specified in the manufacturer's shop manual. This deviation clearly indicated a deficiency in the hydraulic system's ability to generate proper lifting force.

After replacing the EPC solenoid, a follow-up pressure test was conducted. The hoist system pressure was restored to the standard range of 185–190 kg/cm², and the dump body resumed normal lifting performance. The corrective action verified that the failure originated from the EPC control circuit rather than mechanical or hydraulic elements.

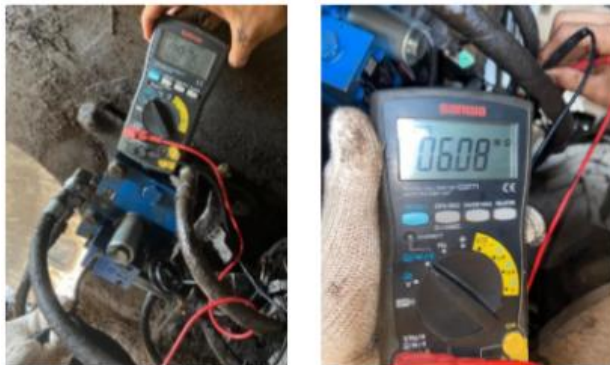
Figure 4. EPC Hoist HEPC Solenoid Measurement

With all mechanical and fluid systems functioning properly, the investigation shifted toward the Electronic Proportional Control (EPC) solenoid, a critical actuator that regulates the hoist valve electronically. Electrical resistance tests were conducted on the solenoid connectors. The readings, summarized below, showed significant deviations from standard reference values.

Solenoid Type	Resistance (Male)	Resistance (Female)
HEPC Solenoid	7 Ω	6.08 MΩ
HSOL Solenoid	25 Ω	11 MΩ

These values were outside the acceptable resistance range indicated in the shop manual, as shown in Table 1, suggesting internal coil degradation, possibly due to thermal fatigue, vibration, or aging of the solenoid windings.

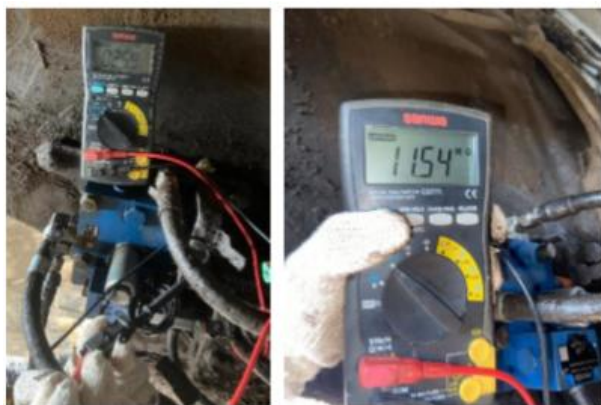
Figure 4. EPC Hoist HSOL Solenoid Measurement

The solenoid’s degraded performance would result in an insufficient electromagnetic force being generated, thus preventing the hoist valve from fully opening and restricting the flow of hydraulic oil to the cylinder. This was confirmed to be the primary cause of the hoist dump power loss.

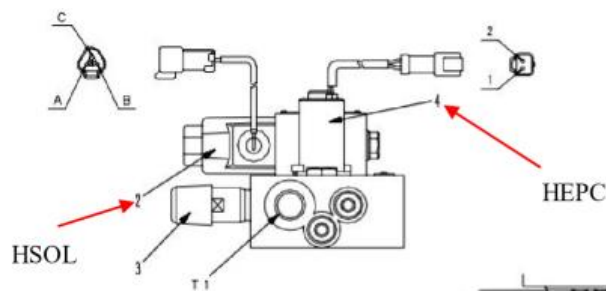
Figure 5. EPC Hoist Structure

Electrical diagnostics revealed abnormal resistance values in both the HEPC and HSOL solenoids of the Electronic Proportional Control (EPC) system. These deviations impaired solenoid actuation, resulting in incomplete valve operation and restricted oil flow. Replacement of the EPC solenoid restored hydraulic pressure to nominal values and resolved the hoist performance issue.

The results confirm that solenoid degradation within the EPC system was the primary cause of the fault. Regular monitoring of solenoid resistance and connector integrity is recommended as part of a preventive maintenance strategy to minimize downtime and maintain operational reliability in heavy duty mining applications.
