## Evaluation of magnetic particle inspection for optimizing welding quality in back gouging boom structure preparation in heavy machinery

Adhe Aryswan, Apriansyah Sutan Hasibuan, Hendra Butar Butar, Tian Havwini, Mega Gemala

Mechanical Engineering Department, Politeknik Negeri Batam

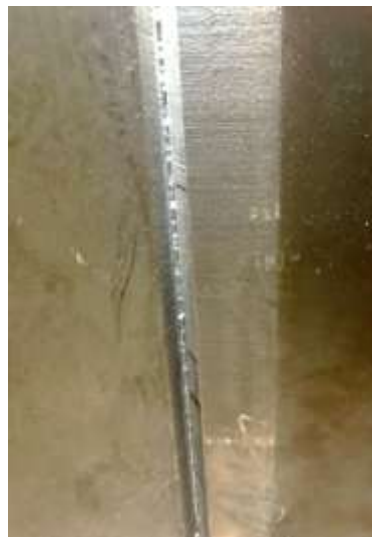
Fig. 4. Welding Seam Before Back Gouging

This study evaluated the effectiveness of Magnetic Particle Inspection (MPI) in detecting welding defects during the back gouging process for boom structures. Data were collected from six Body Serial Numbers (263-268) to compare Defects Per Unit (DPU). The welding process followed the Welding Procedure Specification (WPS), but suboptimal root penetration was observed due to gaps between the plates, as shown in Fig. 4 and Table 5. Factors such as insufficient backing ceramic, inadequate preheating, and poor joint design contributed to these defects.

This finding was attributed to several factors, including the lack of process improvement to add backing ceramic to root preparation, insufficient skills or expertise among welders, joint design with a root face that is too thick, preheating before welding that does not reach the corresponding hot spot WPS, and gaps or root openings that are too wide.

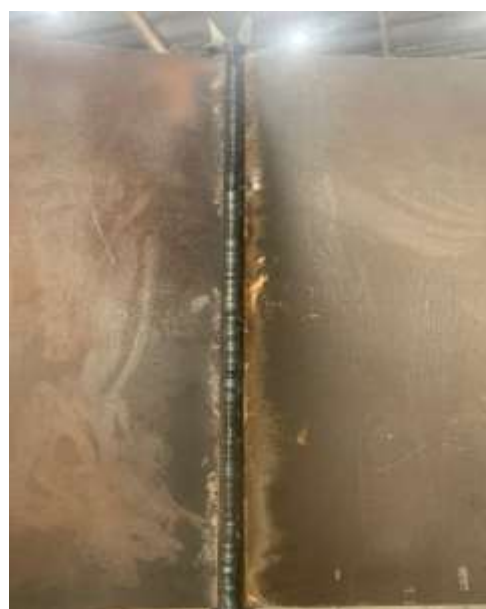
Fig. 5. Welding Seam After Back Gouging Process

Fig. 5 shows that the correct back gouging process yielded good gouging results and uniform grooves. Before conducting the magnetic particle test, as shown in Fig. 6, the joint preparation had to be cleaned of all contamination following the back gouging process.

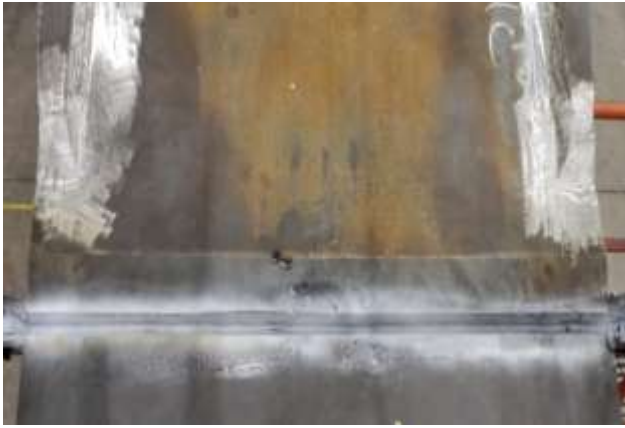
Fig. 6. Welding Seam After MPI Checking

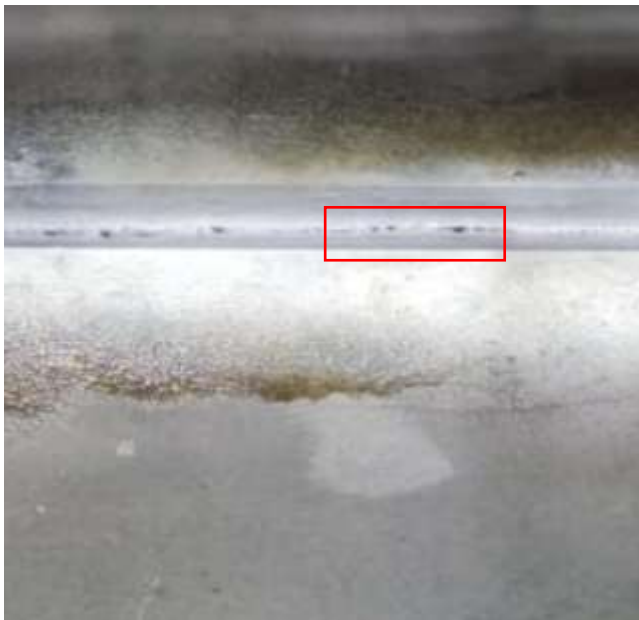
Fig. 7. Linear Indication

Linear indications, caused by surface roughness, contamination, and suboptimal welding parameters, were found across samples, as illustrated in Fig. 7. These indications can occur due to several factors, including suboptimal material cleanliness before welding, which can cause a lack of fusion; using a voltage that is too low, which can also lead to a lack of fusion; and the need for a faster travel speed[11].

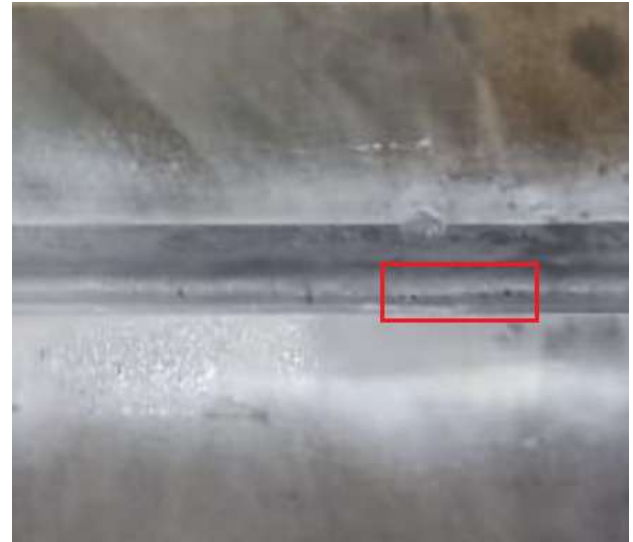
Fig. 8. Rounded Indication

Rounded indications, attributed to porosity and gas flow issues, were less frequent, but still present (Fig. 8). These indications could occur due to porosity during the root process and are caused by several factors, including joint preparation contaminated by water, paint, grease, oil, and other substances; the use of electrodes that are too humid and a lack of preheating before the welding process; strong air or wind gusts that interfere with the flow of shielding gas; gas flow that is too high, causing turbulence and drawing air out; and gas flow that is too low, not providing enough protection for the weld crater[12].
