# ROOT CAUSE ANALYSIS OF COLLAPSEABLE ALUMINIUM TUBE FAILURE ON LJ-60 TYPE IMPACT EXTRUSION PRESS MACHINE USING THE FAULT TREE ANALYSIS (FTA) METHOD

Ezra Esa Jaya<sup>1</sup>, Swandya Eka Pratiwi<sup>1</sup>

<sup>1</sup>Mechanical Engineering Departement, Faculty of Engineering, Mercu Buana University, Jakarta, 11650, Indonesia

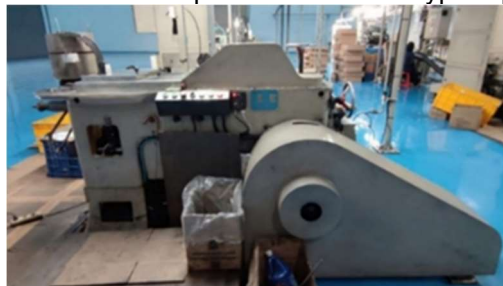
Making collapsible aluminum tubes requires several machines. One machine that plays an important role is the impact extrusion press machine. The impact extrusion press machine that we use is the LJ-60 type. The LJ-60 type impact extrusion press machine is capable of producing extrusions with diameters ranging from  $\varnothing 11.4$  mm to  $\varnothing 18.9$  mm. Below is a picture of the LJ-60 type impact extrusion press machine.

**Figure 1.** LJ-60 impact extrusion press machine (3D)

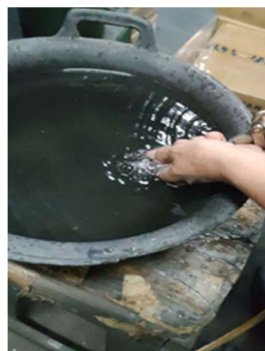
**Figure 5.** Tube Leak Testing

There are several indicators that there is a leak in the aluminum collapsible tube. One of them is that bubbles or foam appear in the water. This process uses a pressure of 6 bar obtained from the compressor. There are seven steps for leak testing.

- Take 10 tube samples from the press machine at random.
- Cut the end of the tube so it is neater and doesn't stick out.
- After that, we spray it using a spray gun from inside, and put it in a bucket filled with water
- If a leak occurs, bubbles and water splashes will appear.
- A good tube will not leak.
- Then we separate the leaking tube and put it in a cardboard box.

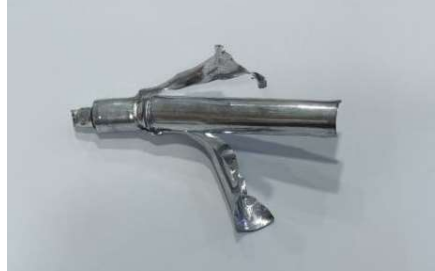
Failure can occur in both impact extrusion press machines and in dies and punches, as well as in vibratory feeder controllers and aluminum collapsible tubes. There are several causes of tube failure, one of which is due to the punch being off-center. This results in the aluminum slug not being able to be pressed properly, resulting in a defective tube. Failures can be overcome using the fault tree analysis method. Fault tree analysis (FTA) is a top-down approach to analyzing failures, starting with a potential event or accident called a top event and determining how the event could [3]. In Figure 6, the damaged tube is illustrated.

**Figure 6.** Extreme Damage to the tube

To reduce and avoid failures, changes and modifications to the system must be made, one of which is the installation of sensors.

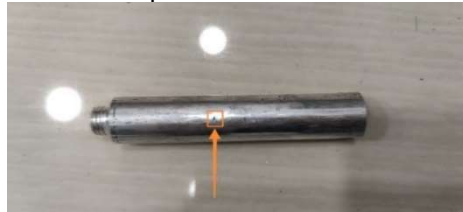
In Figure 7, there is a small leak in the collapsible aluminum tube

**Figure 7.** Leak in the tube

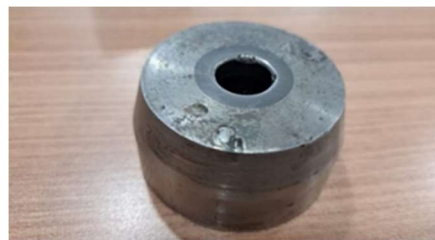
Dies are molds found in impact extrusion press machines. Damage is often found on the dies. This part is made of tungsten, which is generally very hard. One of the damages to the dies occurred because the punch with the aluminum slug was not centered and tilted when extruded. As a result, the surface of the dies becomes lumpy, deformed, and uneven. In Figure 8. This is an example of Damage that occurred to the dies

**Figure 8.** Dies Damage

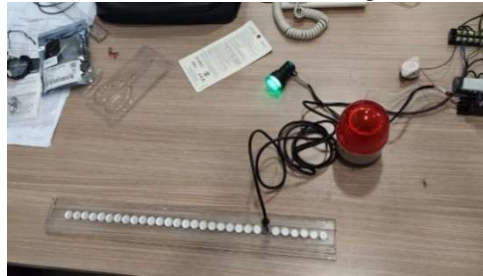
The aim of making this prototype is to test the accuracy and ability of the proximity sensor to detect aluminium slugs. The system is then assembled as shown in Figure 14.

**Figure 14.** Planning system detection of aluminium slugs  
After that, we run the system as shown in Figure 15.
