# Feasibility Analysis of 150 Kv Circuit Breaker (PMT) for Padang Luar 2 Conductor Bay at Maninjau Substation

In this study, the author examines the ALSTOM 150 kV Bay Padang Luar 2 Circuit Breaker (PMT) at the Maninjau Substation.

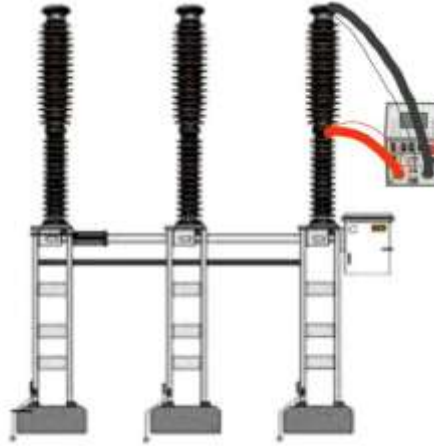
**Figure 3.** Contact Resistance Measurement Using DV Power

The contact resistance of the PMT was measured using a DV power meter. In this measurement, the PMT was injected with a current of 100 A. The contact resistance was measured by measuring the conductor and the outer plate of the PMT. After the measurements were taken, the two tables above were obtained. The two tables above show the following power losses.

From the contact resistance test of PMT 150 kV Bay Penhantar Padang Luar 2 in GI Maninjau, there is 1 phase that has a high contact resistance value or does not comply with the standard (IEC 60694 R value  $\leq 50 \mu\Omega$  / 120% FAT value). Therefore, it is necessary to re-measure to find which point or clamp has a high contact resistance value. From these measurements, the power loss value is very small except for phase S of 5.469 Watts. The smaller the contact resistance value, the smaller the power loss generated by the PMT.

The loose clamp on the PMT and the condition of the PMT clamp, which contains many pollutants, are the main factors that often occur when the contact resistance on the PMT clamp is high. After calculating the loss in rupiah, it tends to be small for 30 days, but this will cause a large loss impact if not addressed further. This high contact resistance can cause hot temperatures (hotspots) when loaded. The higher the load, the higher the hotspot (heat temperature generated). This hot temperature on the PMT can cause PMT malfunction or even breakdown.

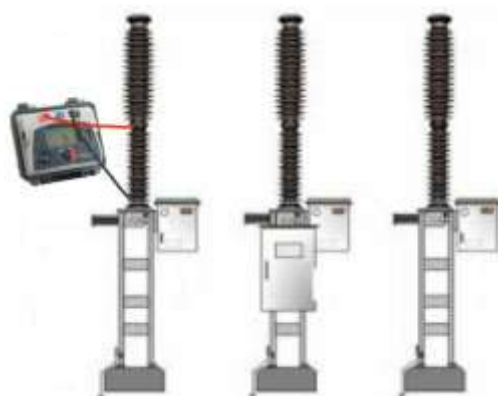
**Figure 4.** Insulation Resistance Measurement Using DV Power

The purpose of this insulation resistance test is to determine the leakage current in a 150 kV PMT. This test is performed when the PMT is open. The insulation resistance test on a 150 kV PMT consists of three tests: top terminal - ground, bottom terminal - ground, and top terminal - bottom terminal.

The results above are the results of injection using a Megger test tool with a DC voltage injection of 5000 V. The following are the results of calculating the amount of leakage current based on measuring the insulation resistance of a 150 kV PMT based on the following formula.

From the results of the leakage current calculation above, it shows that each PMT phase has a different insulation value. This is because the conditions in the Maninjau substation area tend to be humid and often rain, which causes moss pollutants to appear on the outer surface of the 150 kV PMT, therefore causing the insulation resistance values obtained to vary. However, the results of this insulation resistance measurement are still in good condition (above 150 Mega ohms) in accordance with the VDE standard (catalogue 228/4) and the results of the leakage current calculation have met the permitted standard, namely  $1\text{kV} = 1\text{mA}$ .

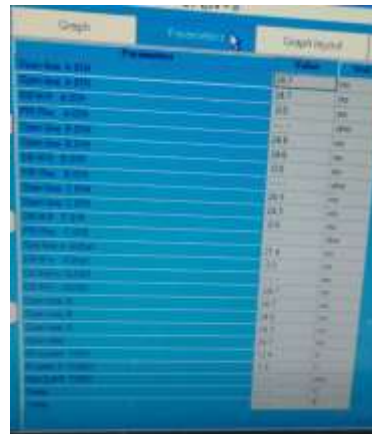
Figure 6. Results of PMT Open simultaneity testing

**Table 6.** Results of the PMT Open Time Simultaneity Test  
Measurement of PMT contact simultaneity

| 1 | Opening hours | R (ms) | S (ms) | T (ms) | Delta t (ms) |
| | Testing | 24.7 | 24.6 | 24.3 | 0.4 |

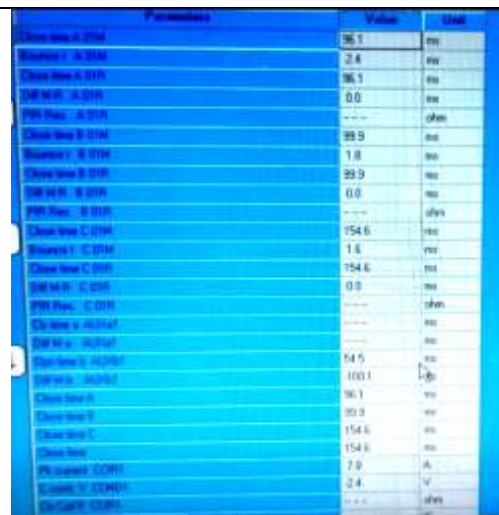
Figure 7. Results of Close Simultaneity Test

**Table 7.** Results of PMT Simultaneity Test for Close Time  
Measurement of PMT contact simultaneity

| 1 | Opening hours (Close) | R (ms) | S (ms) | T (ms) | Delta t (ms) |
| | Test 1 | 96.1 | 99.9 | 154.6 | 58.5 |

The test results listed in the three tables above show that the delta time ( $\Delta t$ ) or the highest and lowest time difference between the R, S, and T phases for the open time shows good results and the close time shows less good results. The test results show that the open time has met the standard time difference value limit, namely  $\Delta t \leq 10$  ms based on the reference from the Alsthom manufacturer and for the closing time or close has not met the standard time difference value limit, namely  $\Delta t \leq 10$  ms based on the reference from the Alsthom manufacturer. So that the PMT can trip according to normal simultaneity performance or its reliability can still be overcome. If the delta time value obtained is above 10 ms, the PMT's simultaneity performance is less reliable (can cause PMT malfunction) but when reclose (OC) occurs because the closing time is above the standard, namely 154.6 ms, this can gradually cause reclose failure because this is also one of the factors or signs of mechanical equipment that must be immediately

maintained. The difference in time difference that is too long results in a surge in current or voltage in other phases which will cause damage to other equipment connected to the PMT, so repairs and retesting are needed on the PMT. However, if the value obtained still exceeds the standard, it is necessary to consider replacing it with a new PMT. If the results obtained during the first and second tests did not meet the established settings, we had to change the settings on the PMT panel. After changing the settings, the result for the third test was 1531.3 ms.

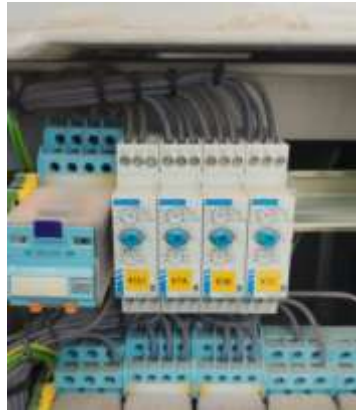
**Figure 8.** KT 6.1 Timer (Pole Discrepancy)

4. The results of the pole discrepancy test of PMT 150 kV Bay Padang Luar 2 at the Maninjau Main Substation after 3 tests accompanied by timer adjustments obtained a result of 1531.3 ms, this is in accordance with the instructions of the main unit regarding pole discrepancy settings.
