## Analysis of Low Voltage Cable Insulation Resistance Test in PT. PLN (Persero) UPP Sumbagut 1 Building

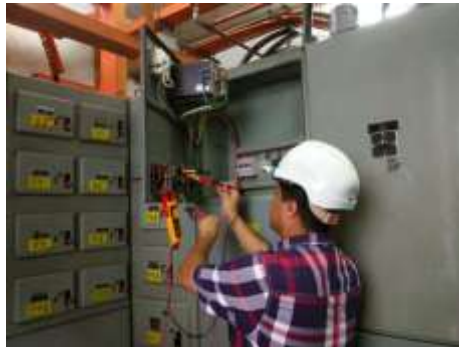
Figure 1. Testing Process with Megger

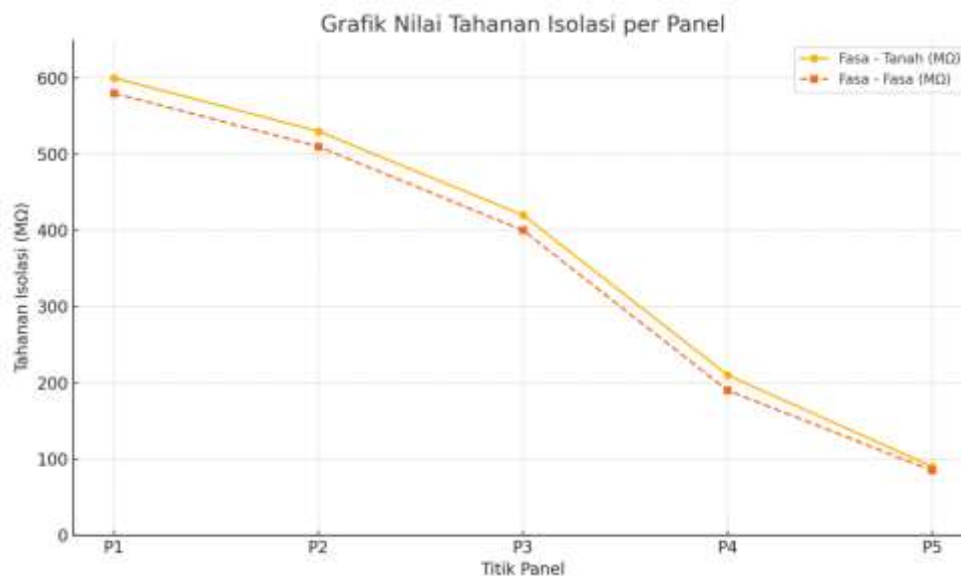
Measurement values for P1 to P3 indicate excellent insulation conditions, well above the minimum standard. P4 has an intermediate result, which is still safe but shows signs of degradation. Meanwhile, P5 has the lowest value and is approaching the critical limit, indicating a decline in insulation quality due to cable age, humidity, or imperfect installation.

Figure 2. Graph of Insulation Resistance Values per Panel

Based on the PUIL 2011 and IEC 60364 standards, the minimum insulation resistance value is 1 MΩ. However, for low-voltage systems, a good value is usually above 100 MΩ. P1 to P3 are categorized as "Very Good," P4 as "Sufficient," and P5 is categorized as "Poor" and requires further action.

Referring to the insulation degradation curve, cables in P1–P3 are estimated to have a remaining operational life of >10 years. P4 is approximately 5–7 years. The P5 cable is recommended for immediate replacement as it has exceeded the critical age and performance thresholds.
