## OVERHEATING OF THE L.O STANDBY PUMP ON THE MAIN ENGINE OF MT. KLAWOTONG

<sup>1,2,3</sup>Semarang Maritime Polytechnic

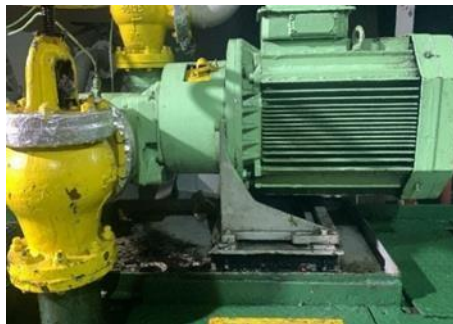
Figure 1. Lubricating Oil Standby pump on board of MT. Klawotong  
Source : Researcher's documentation (2023)

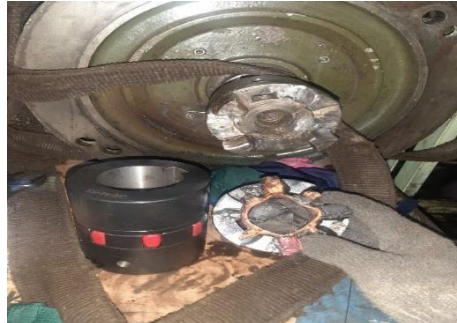
a) Damaged rubber coupling

The rubber coupling serves as a connector between two shafts that can absorb vibrations generated by the engine. With this ability, it can prevent excessive vibration, if the rubber coupling is damaged, it can damage other components.

Figure 6. Damage to the rubber coupling Source: Researcher's documentation (2023)

- 1) Damage to the rubber coupling: The rubber coupling is a component that connects two shafts and functions to absorb vibrations generated by the machine. This ability prevents excessive vibration that can damage other components. If the rubber coupling is damaged, it can affect the performance of the pump and potentially cause more serious problems. Therefore, during operating hours, the engineer must check the condition of the rubber coupling during maintenance.

Routine maintenance is carried out once a week by checking its physical condition and cleaning it from dirt or particles that may be attached. Be sure to clean the parts exposed to fluids, and replace or clean the filter if necessary. In managing engine maintenance, all activities carried out, including visual inspections, must be properly recorded. Whether it is routine maintenance or major repairs, well-managed records are essential to ensure the availability of quality spare parts needed.

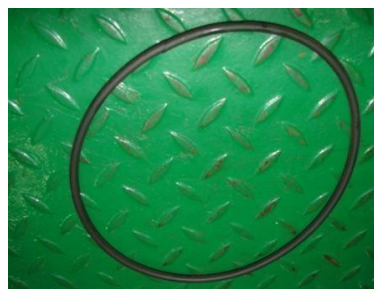
b) Damage to the oil seal

The oil seal is an important component of the pump that functions to prevent leakage or transfer of liquid between two parts of the machine that move relative to each other. If the oil seal is damaged, it will cause leakage.

Figure 7. Damage to the oil seal Researcher's documentation (2023)

- 2) Damage to the oil seal: The oil seal is an important component of the pump that functions to prevent leakage or transfer of fluid between two parts of the machine that move relative to each other. If the oil seal is damaged, it can cause leakage that impacts the performance of the pump.

Monitoring the temperature and pressure of the L.O. standby pump is an important step to prevent overheating or overpressure which can reduce pump performance. Parts that are worn or damaged can interfere with pump performance and increase the risk of failure. Carry out regular inspections of spare parts such as oil seals, rubber couplings, bearings, or gears and replace them immediately following correct operating procedures.
