## Analysis of Factors Causing Delays in Coal Loading on the MV TAI SPRING Due to Fire in the Cargo

Awel Suryadi<sup>1</sup> ◦ Syaefulah Hidayat<sup>2</sup> ◦ Andi Prasetyawan<sup>3</sup> ◦ Iwan Kurniawan<sup>4</sup>

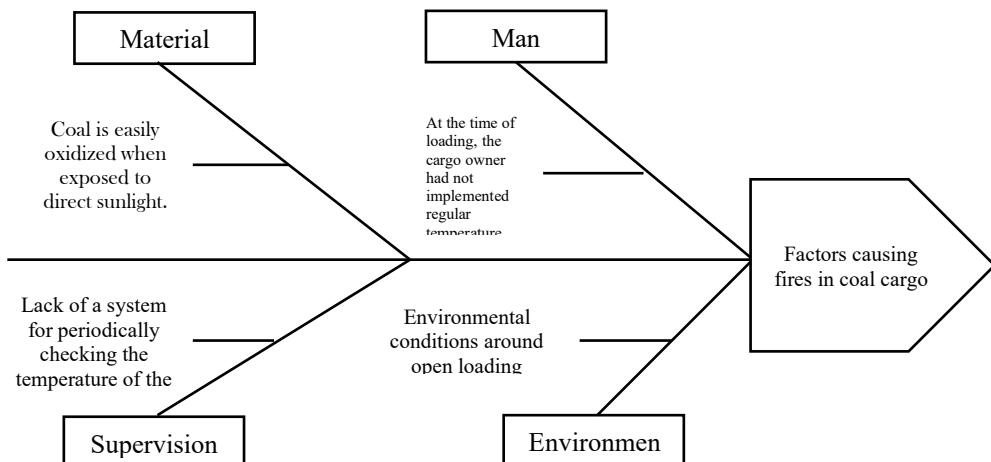
Table 1. Factors causing cargo fires during the coal loading process on the MV TAI SPRING

Environmental conditions around coal loading areas and direct exposure to sunlight can accelerate chemical reactions in coal, especially if not balanced with proper cargo handling.

A weak cargo monitoring system results in delays in detecting increases in cargo temperature. The lack of a regular cargo temperature checking system slows down the early detection and response to fire threats.

Based on the analysis, the fire that occurred in the coal cargo during the loading process on the **MV TAI SPRING** was caused by several main factors, namely human, material, environmental, and supervision aspects. The lack of regular temperature monitoring was a significant initial cause. Furthermore, coal, as a dangerous cargo, is flammable and requires special handling. The open environment and direct exposure to sunlight accelerate the self-heating reaction, which becomes even more risky if not balanced with adequate safety measures. The lack of monitoring of the cargo temperature also exacerbated the situation, so an evaluation of the monitoring system is needed to prevent similar incidents in the future.

1. Identify hazards before operation by checking the temperature of the load.
2. Inspect the area and equipment, ensuring complete PPE.
3. Use an excavator or bulldozer to open and remove any coal piles that are hot or emitting smoke.
4. Separate the burning material, spread it in a safe area, and extinguish it by pressing it with the excavator or bulldozer bucket.
5. Mix the material to eliminate air pockets and compact it to prevent the fire from rekindling.
6. Once the fire is confirmed to be extinguished, report it to the supervisor.
