## INDONESIAN JOURNAL ON GEOSCIENCE

### Analysis of Lithological Aspects and Their Influence on Slope Stability of the Failed Riverbank in Ajil, Hulu Terengganu, Malaysia

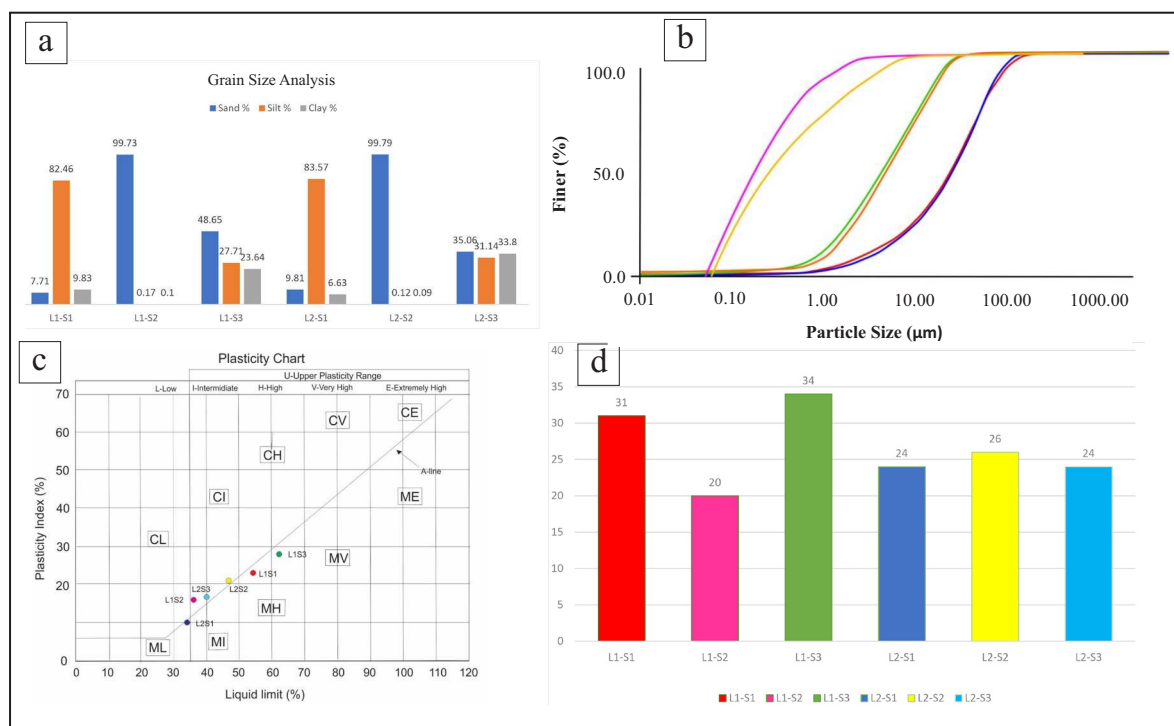
Soil samples L1S2 and L2S2 showed a high percentage of sand (>90 %), while the other samples had higher proportions of silt and clay (Figure 4a). The obtained grain size distribution data were presented in a graph, and the results classified each sample differently, although silt dominated the percentages (Figure 4b). Each sample was also analyzed to determine the uniformity coefficient (Cu) and the coefficient of curvature (Cc) to assess the grading quality of the particles. The calculations were based on cumulative distribution values at particle sizes D<sub>10</sub>, D<sub>30</sub>, and D<sub>60</sub>, as shown in the cumulative distribution graph (Table 1). From the calculations, the uniformity coefficient (Cu) ranged from 3.6 to 9.81. The coefficient of curvature (Cc) for samples L1S1, L1S2, and L2S1 ranged from 1.05 to 1.66, while samples L1S3 and L2S3 showed values of 0.63 and 0.71. Based on this information, samples in the L1S1, L1S2, L2S1, and L2S2 areas are categorized as well-graded, while samples in the L1S3

Figure 4. a) Grain size analysis chart of five samples. b) Particle size distribution graph showing positive-negative skewness comprising coarse-fine to silt-clay grains samples. c) Plasticity Chart plotted of each sample. d) Percentage of plasticity limits for each sample in the studied area.

Plastic limit tests indicated that sample L1S3 had the highest percentage at 34 %, followed by sample L1S1 at 31 %, sample L2S2 at 26 %, sample L2S3 at 25 %, and samples L1S2 and L2S1 at 24 % and 20 %, respectively (Figure 4d). Table 2 details the plasticity index values for each sample type. Calculations show plasticity indexes ranging from 10 % to 28 %, with notably high plasticity indexes in samples L1S1, L1S3, and L2S2. Soil classification was based on data plotted on the plasticity chart. According to the Unified Soil Classification System (USCS), analysis indicated that samples L1S2 and L2S2 fell above the A-line, and were classified as clay. Meanwhile, samples L1S1, L1S3, and L2S1, falling below the A-line, were classified as silt. Samples L1S2, L2S2, and L2S3 were categorized as CI, indicating clay with moderate plasticity.

Given their liquid limit below 50 % per ASTM D2487 classification, they are regarded as clayey silt. Samples L1S1 and L1S3 were classified as MH, referring to silt with high plasticity. Sample L2S1 was categorized as ML due to its liquid limit falling within the 34 % range, denoting a low plasticity index (Figure 4c). Soil failure occurs when it reaches its maximum stress level at a specific strain value. Plastic soil can endure an increase in strain within the soil. Soil failure due to peak stress may continue to bear stress, albeit with diminishing stress levels. According to Holtz and Kovacs (1981), soil that is semi-solid or brittle can withstand maximum applied stress, but will fail immediately afterward.
