# Damage Detection in Gusset Plates of Steel Truss Bridges using Modal Parameters: Experimental and Numerical Study

Kristijanto, H.<sup>1\*</sup>, Fitriyah, D.K.<sup>2</sup>, and Habieb, A.B.<sup>1</sup>

<sup>1</sup> Department of Civil Engineering, Sepuluh Nopember Institute of Technology, Surabaya, INDONESIA

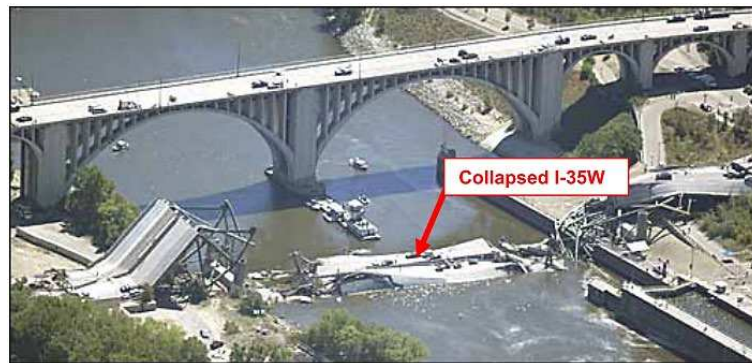
**Figure 2.** Photograph of the I-35W Bridge Collapse [2]

The gusset plate, which connects the main truss to the deck, is crucial to structural integrity. Corrosion in this area can cause cracks that spread under load [1], potentially leading to progressive collapse (Figure 2) [2].

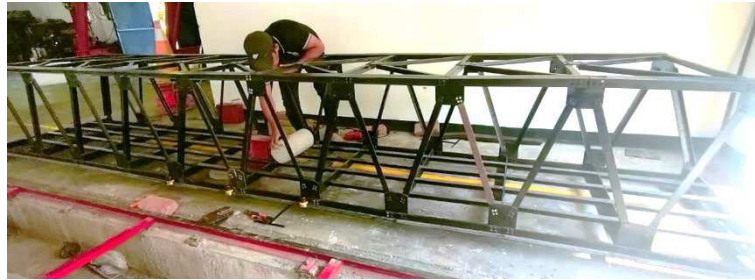
**Figure 8.** Experimental Set-up of 5% Cut Damage on Gusset Plate at Mid-span

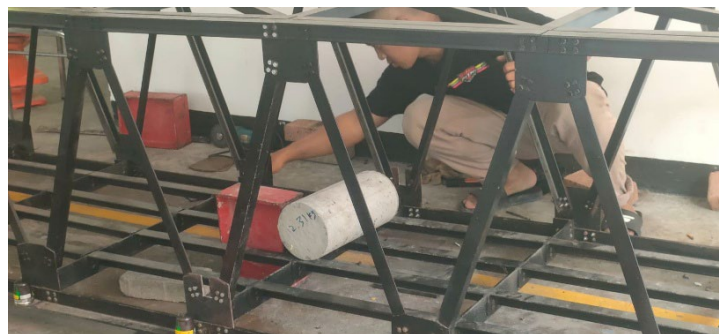
**Figure 12.** Experimental 10% Tearing Damage on Gusset Plate at Mid-Span

This section evaluates the 10% cut damage scenario on the gusset plate at mid-span. As shown in Figure 11, a 10% artificial cut was introduced in the structural model, with displacement modes analyzed at observation points matching the experimental setup (Figure 12). FEM results are also presented in Figure 11.

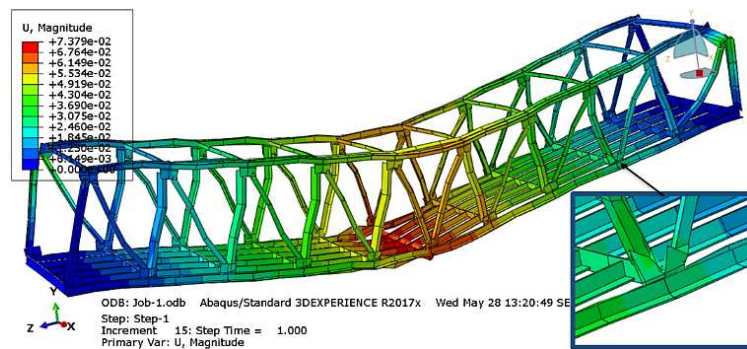
**Figure 18.** Bridge Modal Analysis with 5% Cutting Damage of the Gusset Plate at 1/5 of the Span

Figure 18 shows the structural model with 5% gusset plate damage at 1/5 span. Displacement modes were analyzed at each point, with measurement positions adjusted to match the experimental setup. Finite element results are visually presented in Figure 18.
