Tactical Activities to Improve the Effectiveness of Concrete Batching Plant Based on Overall Equipment Effectiveness Analysis

Yurida Ekawati*, Iddo Christian Sutrisno, Teguh Oktiarmo

*Department of Industrial Engineering, Universitas Ma Chung, Villa Puncak Tidar N-1,
Malang, 65151, Indonesia*

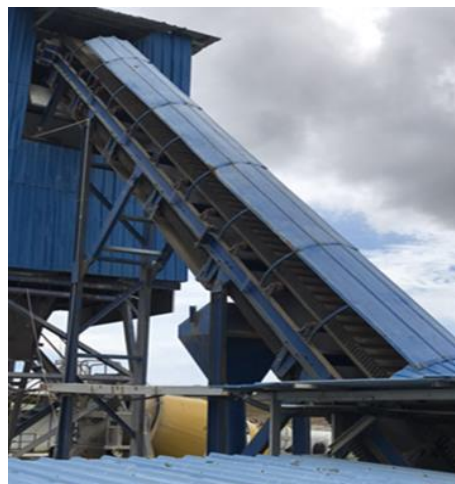
Fig. 1. Bucket

Availability losses disrupted the availability or reliability of the machines and several components. Table 4 showed that there were losses in each component of the batching plant (weighing system, mixing system, conveying system, storage system, and control system). The factors causing the majority of losses were found in the conveying system. In conveying system, there were compressors, cement conveying pipes, and buckets (Figure 1).

Another source of losses occurred with the buckets, which became dirty due to residual material that had not been properly discharged. Additionally, the buckets did not always occupy the position where they were supposed to receive material from the conveyor, causing the material to fall and go to waste. This problem was often caused by the steel cables experiencing tension disturbances due to excessive friction on the bucket drive pulley. The heat generated caused the lubricant oil for the pulley to reach high temperatures, which slightly hindered lubrication and resulted in increased friction forces. Another constraint related to the machinery involved the pipes that were responsible for conveying the material. The most common damage to the pipes was found in the cement conveying pipes due to detached distributor valves.

The issues that frequently arose with the bucket included dirt accumulation and unstable tension in the steel cable. The unstable tension was caused by insufficient lubrication in the pulley, which necessitated regular inspections to ensure that the pulley was in good working condition. Additionally, a routine cleaning schedule for the interior of the bucket was required.

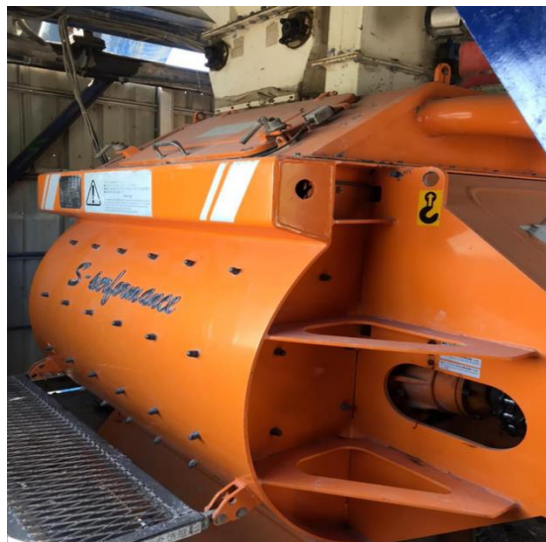
Fig. 2. Mixer

The subsequent losses were observed in the mixing system, which comprised the mixer (Figure 2) as its primary component. Common problems with the mixer included residual material and the drive motor not functioning properly due to insufficient electrical current or inadequate power to operate the machine. In the storage system, the causes of availability losses were associated with the cement silos (Figure 3). Losses in silos are caused by operators such as silos being overloaded and silos not closing properly due to lack of supervision by operators.

In the mixing system, the proposed solutions to minimize failure included conducting routine cleaning and having readily available spare parts when the mixer's drive motor failed to operate. Additionally, regular cleaning of the mixer was essential. The cleaning process involved introducing a solvent solution into the mixer, after which the drive motor would be activated to remove residual concrete from the pan mixer. Disposal of the cleaning solution

had to be carried out according to established procedures to prevent environmental contamination. Furthermore, the operators were required to remain vigilant and disciplined in inspecting the mixer components, as the quality of the concrete was determined during the mixing process. In addition to maintaining the cleanliness of the pan mixer and drive motor, two key factors needed attention to prevent failure to the components in the mixing system: the capacity of the pan and the mixing speed had to align with the existing standards. The capacity of the mixer was 5 m³, and the mixing speed was set at 14-20 revolutions per minute.

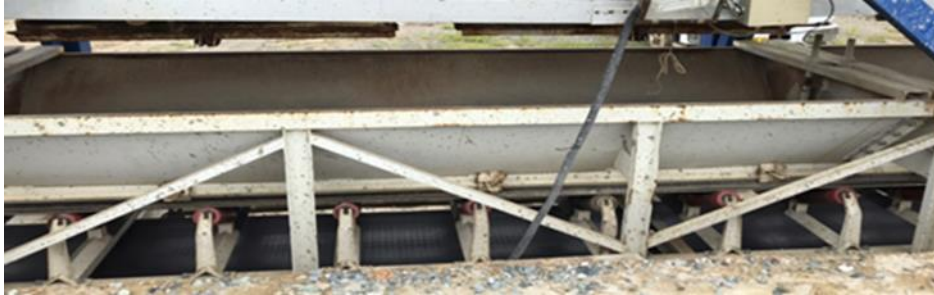
Fig. 4. Hopper

Next, in the weighing system, the most crucial equipment was the hopper (Figure 4). Errors in the hopper could occur if it was not cleaned of residual material during the production process. In addition to residual material, inaccurate scales could also contribute to errors in weighing, resulting in defects in the final product. Scale inaccuracies were typically caused by the hopper's interface overheating, which led to imprecise measurements. Additionally, mixtures that were too wet occurred when the aggregate material measurements from the hopper and the water volume from the tank, as regulated by the flow meter, were not aligned. The standard tolerance for aggregate measurements was $\pm 0.5\%$, meaning that if the mixture was too wet, the measurement exceeded 0.5%.

In general, the solutions proposed for the weighing system included calibrating the hopper to ensure accurate measurement. Calibration could be performed at least once a month. In addition to calibration, several components in the weighing section were found to be failed due to dirt or burning. The unstable electrical voltage caused some components in the hopper to burn out quickly, highlighting the need to check the electrical voltage before operating the system. Routine cleaning of each component was also necessary to prevent failure caused by dirt accumulation in the machine.
