## **Community Service Group on Seagrass Ecosystem Management in the Coastal Area of Laikang Village, Takalar Regency**

**Abstract.** Seagrass ecosystems play a vital role in both the ecology and economy of coastal regions. Ecologically, seagrass beds serve as nursery grounds, spawning grounds, and feeding

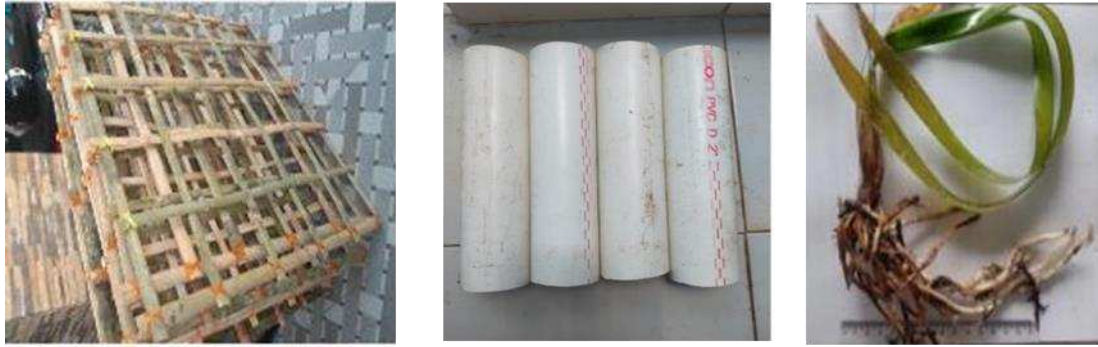
**Figure 2.** Bamboo frame, pipe, and seagrass seedlings (*Enhalus acoroides*)

Before planting, the tools and materials to be used in the planting process are prepared (Figure 2). The tools and materials used are: 1) A machete or saw, 2) A small shovel for digging, 3) Pipes cut into 25-cm lengths, 4) Metal rods for support, and 5) Containers for the seagrass seedlings.

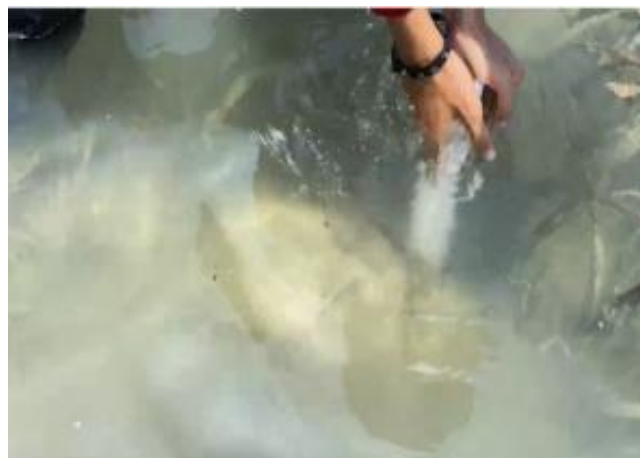
**Figure 3.** The process of collecting seagrass seedlings along with the substrate using PVC pipes as a transplantation medium.

**Plug method**, is a seagrass rehabilitation technique that involves transferring seagrass seedlings along with their natural substrate to a rehabilitation site. This method aims to maintain the stability of the seagrass roots and growing medium, thereby increasing the success rate of transplantation. Seagrass donor samples are collected near the transplantation site to minimize plant stress and ensure that the environmental conditions of the source site match those of the planting site. Seagrass seedlings are collected using PVC pipes while preserving their natural substrate to maintain stable root and growing medium conditions, ensuring that the seedlings remain fresh and are able to adapt well after transplantation. The process of collecting seagrass seedlings along with their substrate using a PVC pipe is shown in Figure 3. This technique involves inserting the PVC pipe into the substrate until the seagrass seedlings, along with the sediment inside, can be lifted intact. Subsequently, the collected seagrass seedlings are planted in pre-prepared holes using a PVC pipe of the same size as that used during the seedling collection process. After the planting process is complete, the PVC pipe is left in place for approximately 14 days to protect the transplanted seedlings from the effects of ocean currents and waves during the initial adaptation period. After this adaptation period, the PVC pipe is then slowly removed so that the seagrass can grow and develop naturally in its new environment.

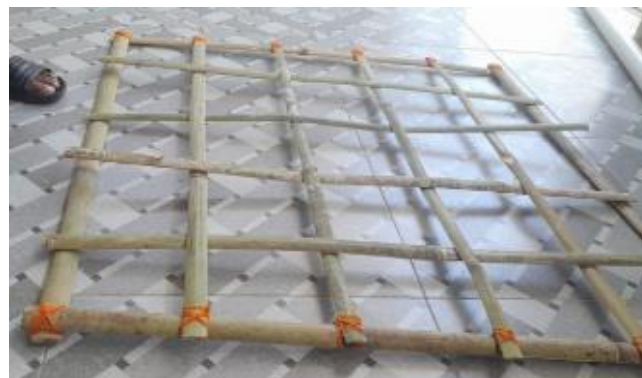
*Figure 4. Shape of the bamboo frame used*

The bamboo frame method begins with the creation of a  $1.25 \times 1.25$  m transplant plot divided into 25 sections, with a spacing of approximately 25 cm between sections. The plot is constructed using bamboo to support the seagrass seedlings during the rehabilitation process. The shape and design of the bamboo frame used in the transplantation activity can be seen in Figure 4. The use of the bamboo frame aims to maintain the stability of the planting area and facilitate the arrangement of seagrass seedlings at the rehabilitation site.

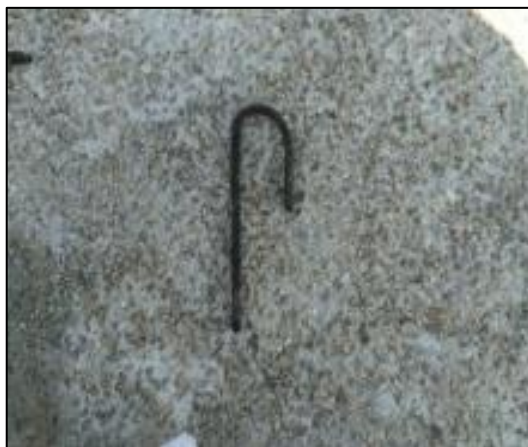
*Figure 5. Plot retaining iron anchor (Permatasari et al., 2017)*

Next, iron anchors are prepared to reinforce and secure the plot, ensuring it remains stable against the effects of currents and waves. The anchors consist of four pieces of iron with a diameter of approximately 12 mm and a length of 50 cm for each corner of the plot, as well as 50 pieces of iron with a diameter of approximately 5 mm and a length of 20 cm, used to clamp and secure the seagrass seedlings to the substrate. The shape of the iron anchors securing the plot can be seen in Figure 5.

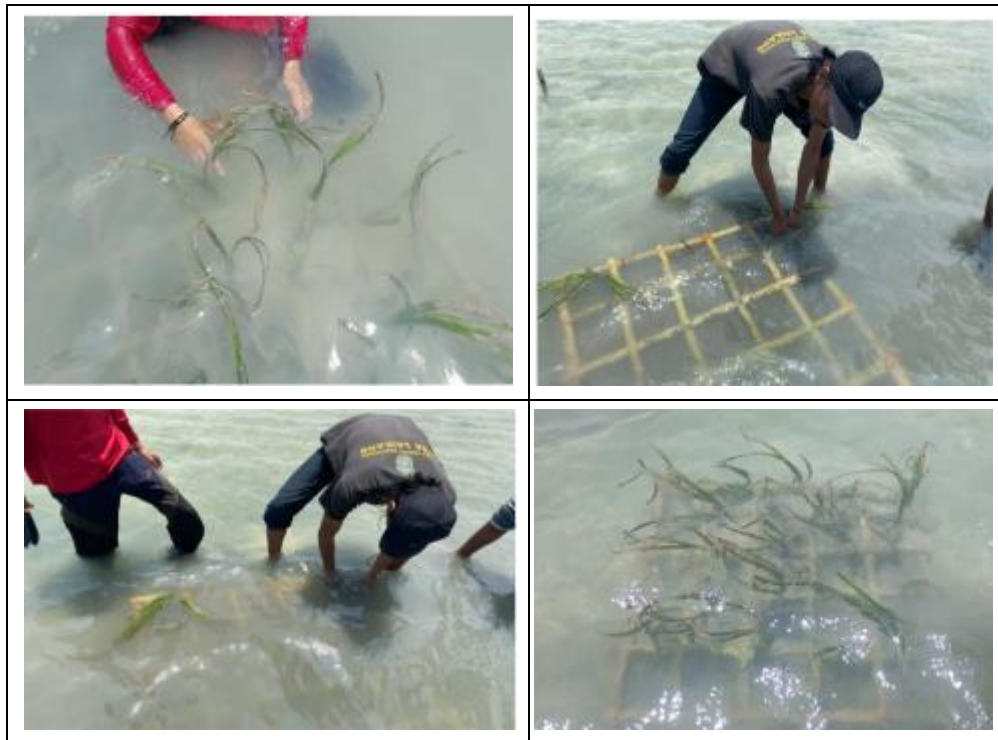
**Figure 6.** Seagrass planting using the sprig-anchor method on a bamboo frame

The next step is installing the plots at the transplantation site by driving the iron anchors into each corner of the bamboo frame. Seagrass seedlings are collected from the donor area using a crowbar driven into the substrate at an angle of approximately 30°, then rotated clockwise until the seagrass seedling is lifted along with a portion of its substrate. After that, a planting hole 3–5 cm deep is made at the transplant site, then the seagrass seedling is placed into the hole and secured using the metal anchor to keep it stable. The hole is then covered again with natural substrate. The process of seagrass planting using the sprig-anchor method on a bamboo frame is shown in Figure 6.

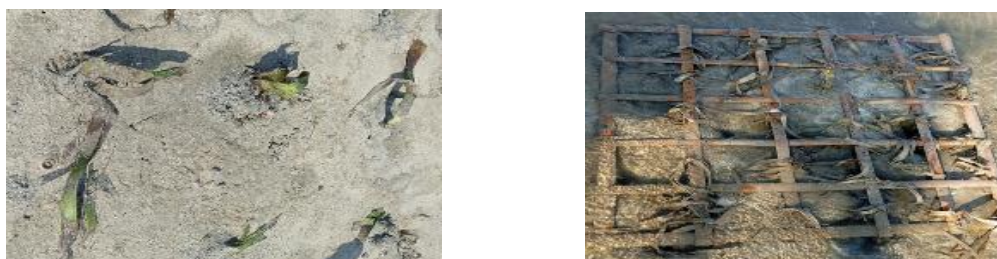
**Figure 7.** Condition of the seagrass after planting; the roots are growing well

After about a month, our team went to the field to evaluate and monitor the results of the seagrass planting using the plug and bamboo frame transplantation method. The monitoring results showed that the plants on the pipes and the upper parts of the bamboo frames had dried out due to exposure to sunlight during low tide; however, the lower parts (roots) remained strong and the seagrass was growing well (the leaves were still green), with a survival rate of 70%. When we conducted the transplanting activity in the field, the water level had already risen (high tide), so we were unable to identify the areas that were still flooded during low tide. The monitoring results can be seen in Figure 7 below:
