# ANALYSIS OF ROCK QUALITY AND LANDSLIDE POTENTIAL IN NORTH JERING HILLS, SLEMAN, YOGYAKARTA

**Abstract** — The purpose of the research was to identify the type and direction of potential landslides and assess the quality of rocks on the slopes of North Jering hills. The data was collected using the scanline method, measuring the plane of failure. The collected data includes the direction, slope level, and condition of the plane of failure, according to the parameters in the RMR table (Bieniawski, 1989). The slope was analyzed kinematically using stereographic projection, and the quality of the rock mass was analyzed based on the weighting results of RMR parameters. The results of the slope's kinematic analysis indicate the potential for a planar avalanche. The RMR value at the research site is 80, which falls under the good rock category. Recommendations for slope strengthening include the use of rockbolt geotechnical engineering with shotcrete or retaining walls.

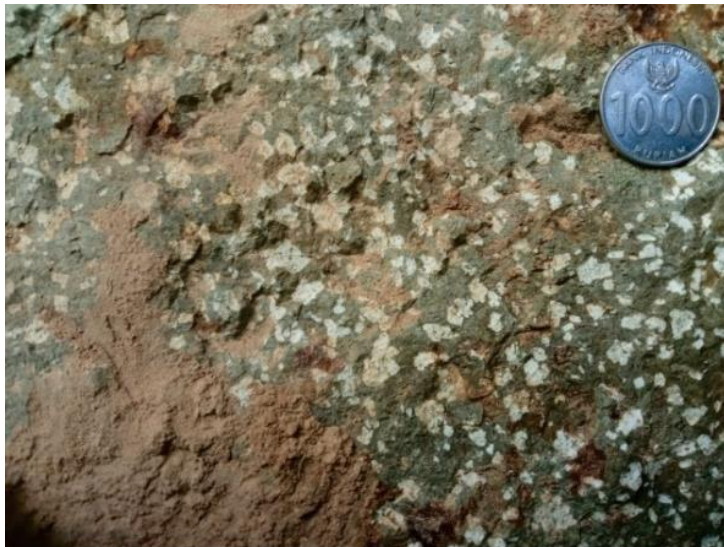
Figure 4 Close-up photo of diorite lithology.

Based on field observations, the lithology on the slopes in Jering Hills consists of intermediate plutonic igneous rock. The rock has a fresh gray color and a brownish-beige weathered color. It has a hypocrystalline degree of crystallinity with fine to medium faneric granularity (1-5mm). The crystal shape is euhedral to subhedral, and the relation is inequigranular (hypidiomorphic). The rock is composed of plagioclase, k-feldspar, hornblende, pyroxene, and quartz. According to William's (1954) classification of igneous rocks, the lithology in question is a diorite (Figure 4)[13]. Harjanto's stratigraphic comparability column (2011)
