# Motor Control Center Breaker Modification Through On/Off Switch to Prevent Motor Failure \*

<sup>1</sup>Department of Electrical Maintenance, PT. PLN Indonesia Power Pro POMU, Jakarta, Indonesia

## Abstract

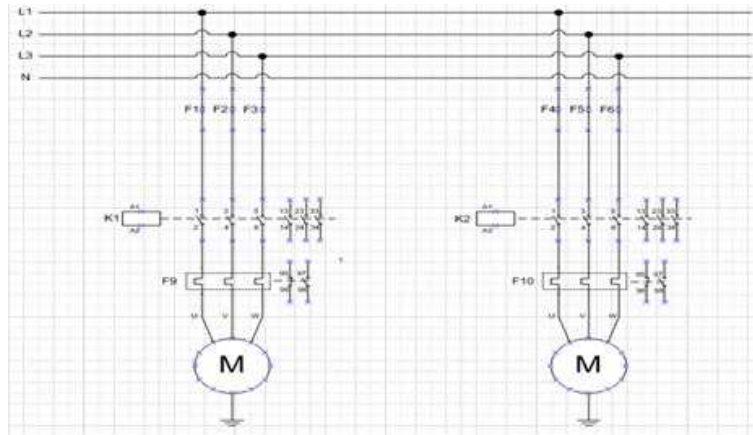
Figure 1. Power Network

Wiring diagrams are used to find out the details of the relationship between each electrical component, usually for this circuit it is a simplification of a circuit, a description of the number and connection pictures. So it will be easy to find the problem and solve it. Wiring diagrams are divided into 2 types, namely power diagrams and control diagrams. The power diagram is a series of motor main voltage lines, where the current flow to the motor is determined by the condition of the contact children of the main contactor.

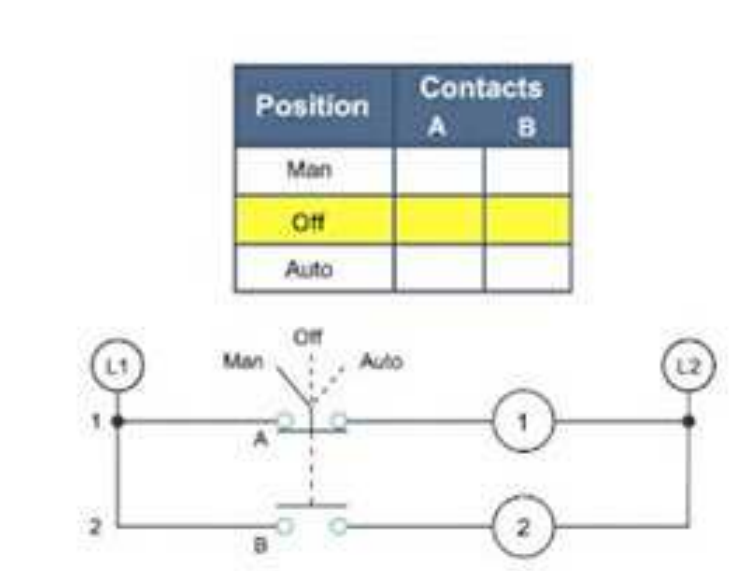
Figure 4. Switch Selector Structure

Switch selector is an electrical component that is outside the electrical panel that functions as a mode selector or change the direction of electric current that works by turning right or sending from the switch selector. The principle works when the switch selector is rotated to the right which was originally on the left, the current will flow towards the N/O or N/C contacts of the Right selector. The term selector chooses but in electrical components the selector serves to move electric current from the block contact to the other block contact.

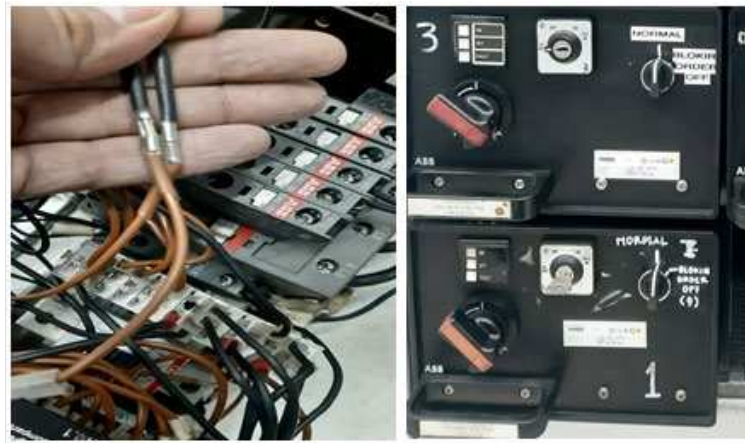
Figure 7. On/Off Switch Modification Result

Currently, additional order off switches have been installed and used in unit operation (shown in figure 7). For example, the condition when the unit starts up, the Generator Cooling Water Pump (GCWP) motor often changes over (CO) between pump no 1 to pump no 2. When the CO process continues, the motor will experience continuous inrush currents which will cause one of which is a broken fuse breaker and can cause a Lost Phase so that the motor will only receive 2 phases or 1 phase depending on the number of broken fuses. So, the installation of this modification can prevent similar accidents occur.

After the installation of this modification, there is no *force outages* or *force derating* occurs caused by breaker failures, which means the modification is proven to make a better result.
