## Architectural Restoration of the Tegalsari Grand Mosque, Jetis, Ponorogo, East Java (1994–1997 CE)

### ABSTRACT

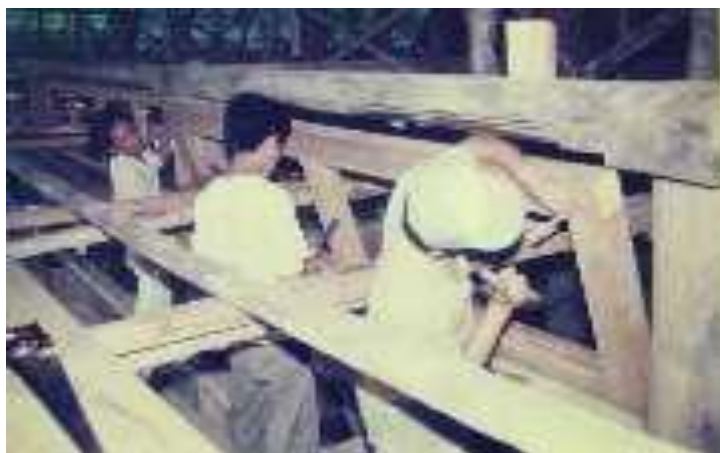
Figure 1. Photograph of the Installation of Wooden Wall Beams and Ventilation

The *serambi* of the Tegalsari Grand Mosque is divided into two sections: the older *serambi*, rectangular in form and measuring 16.20 × 13.56 meters, supported by 12 teak wood pillars; and the newer *serambi*, constructed with assistance from President Soeharto in 1978, measuring 16.25 × 6.90 meters. The main prayer hall of the mosque is likewise square in plan, measuring 16.20 × 16.25 meters, and is supported by 36 pillars, including four *saka guru* made of Pulung teak wood. On the western side of the main prayer hall is a *mihrab* measuring 2.06 × 1.30 × 2.17 meters, adorned with carved vegetal (*sulur-suluran*) motifs. In addition, there is a teak wood *mimbar* (pulpit) decorated with floral and vine ornaments, reinforcing both the aesthetic and symbolic dimensions of the space. These elements demonstrate the richness of traditional ornamental vocabulary in Javanese mosque architecture.

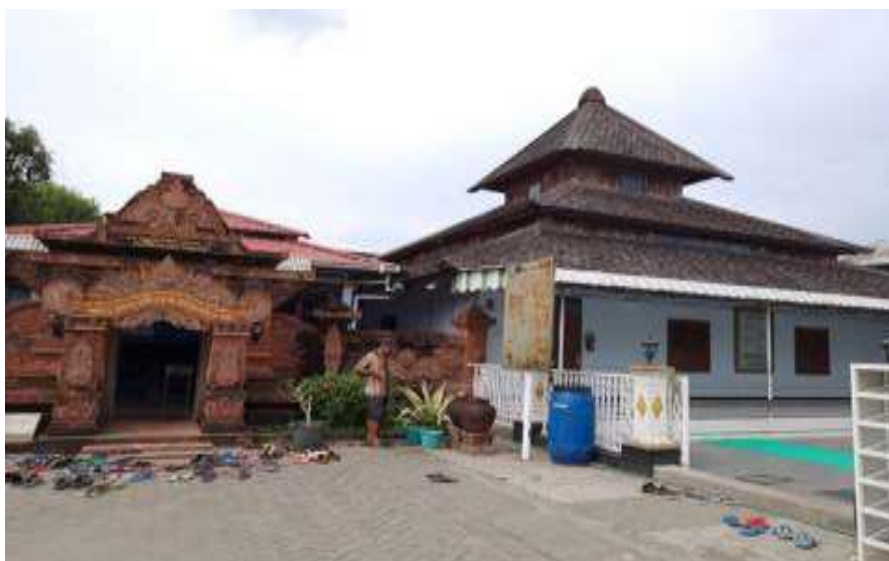
Figure 2. Photograph of the Three-Tiered Roof of the Mosque  
Source: author's documentation

The mosque's three-tiered (*atap tumpang*) roof carries complex symbolic meanings, functioning both as a representation of *shari'a*, *ma'rifa*, and *haqiqa*, and as a symbol of *Iman*, *Islam*, and *Ihsan*. At its apex stands a *kemuncak* in the form of an inverted earthen jar, which serves as an ornamental feature as well as a talismanic element intended to ward off misfortune, in accordance with local traditional beliefs. The mosque's fence, designed with curved forms projecting outward, is interpreted as a symbol of Allah's protection over the Muslim community from satanic disturbances and external threats. The presence of the tomb of Kiai Ageng Muhammad Besari within the mosque complex further reinforces the symbolic relationship between life and death, in which the mosque is understood as a space of piety and the tomb as a place of repose on the journey toward the hereafter (Salsabila, [2024](#)). Accordingly, all architectural elements of the Tegalsari Grand Mosque integrally reflect the synthesis of Islamic teachings, local traditions, and the spiritual values of Javanese society (Multazam, [2021](#)).

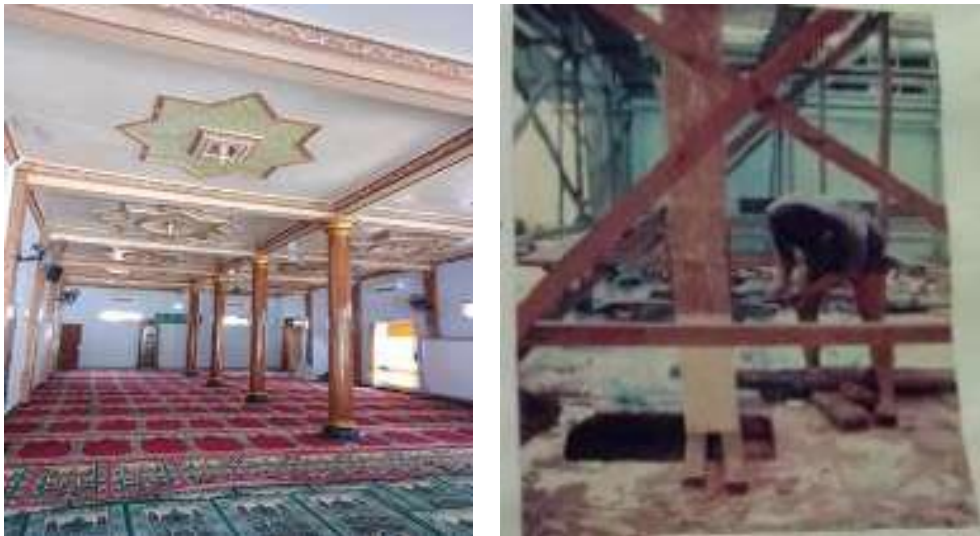
**Figure 3. The Pawestren Space and the Process of Cutting the Serambi Columns**

In the *serambi* area, dismantling was carried out comprehensively on the roof covering, structural frame, and columns, which were remnants of previous renovations. Non-original materials were separated for replacement, while original elements such as *usuk*, *blandar*, *jurai*, and truss columns were marked and registered so that they could be reinstalled in their original positions. The *serambi* floor was then dismantled to trace the presence of original *umpak* foundations concealed beneath layers of soil. Excavation revealed twelve andesite stone *umpak* with trapezoidal forms, which constituted an important component of the ancient mosque's structure. These *umpak* were conserved through thorough cleaning and the application of waterproof coatings to ensure the stability of the structural elements above them (Setyawan et al., [2017](#)).

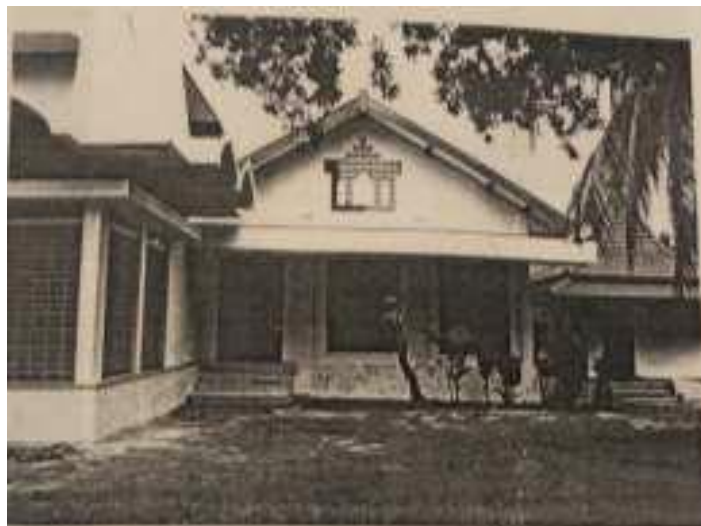
Figure 4. Photograph of the Restored Pawestren Viewed from the Front  
Source: Cultural Heritage Preservation Agency (BPCB) East Java
